# COMPRESSED AIR LEAK DETECTION SURVEY

**September 2020**

The survey was carried out at **On Line Vibration Monitoring Ltd on the 17<sup>th</sup> & 18<sup>th</sup> September 2020** using an ultrasonic leak detection instrument. Digital images of leak sites were taken for positive identification purposes. The whole site was surveyed including production plants, distribution systems and services.

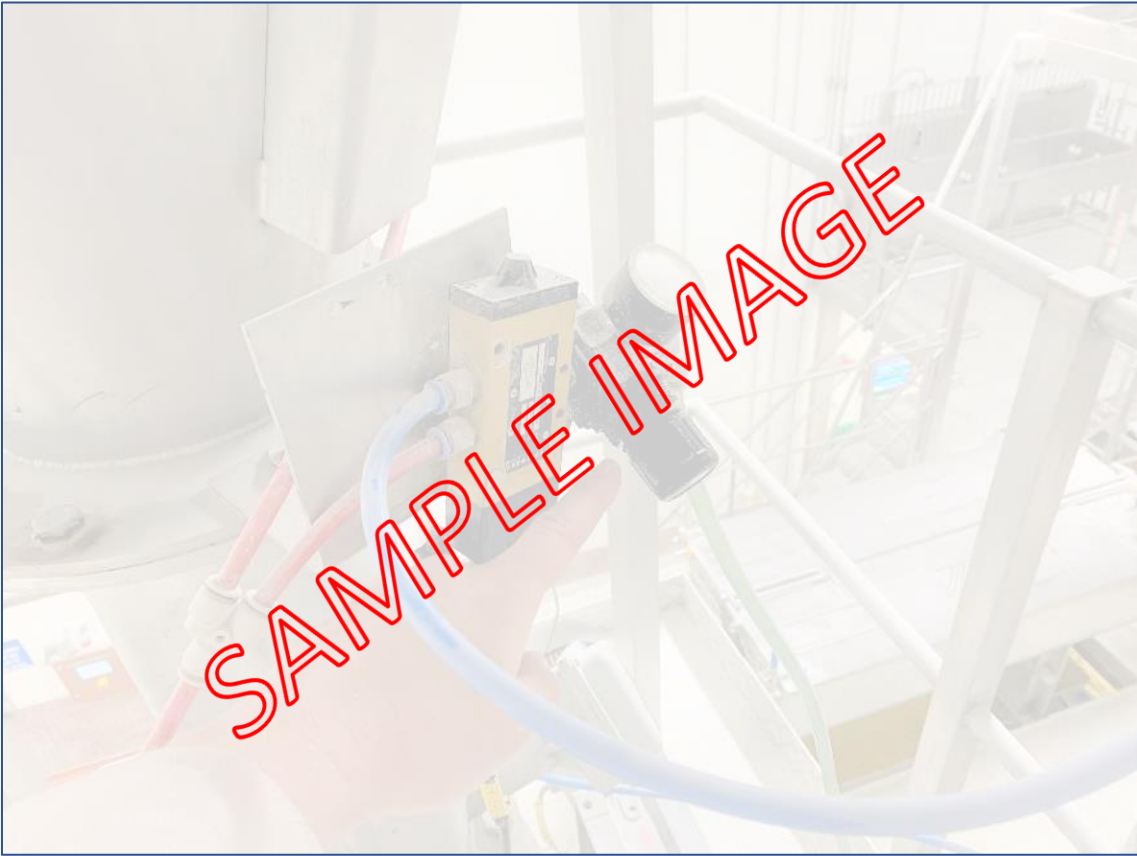
**Leak No.1**

Leak No.	Location of Leak	Nature of Leak (Location, Description)	Severity of Leak (1-10)	Estimated Leak Size (cfm)	Estimated Max Cost (£)	Photo
1	Ingredient mezzanine area upper level - Line A flour hopper fluidiser - Pressure regulator	Air passing from base of adjuster knob	2	1.2	220.93

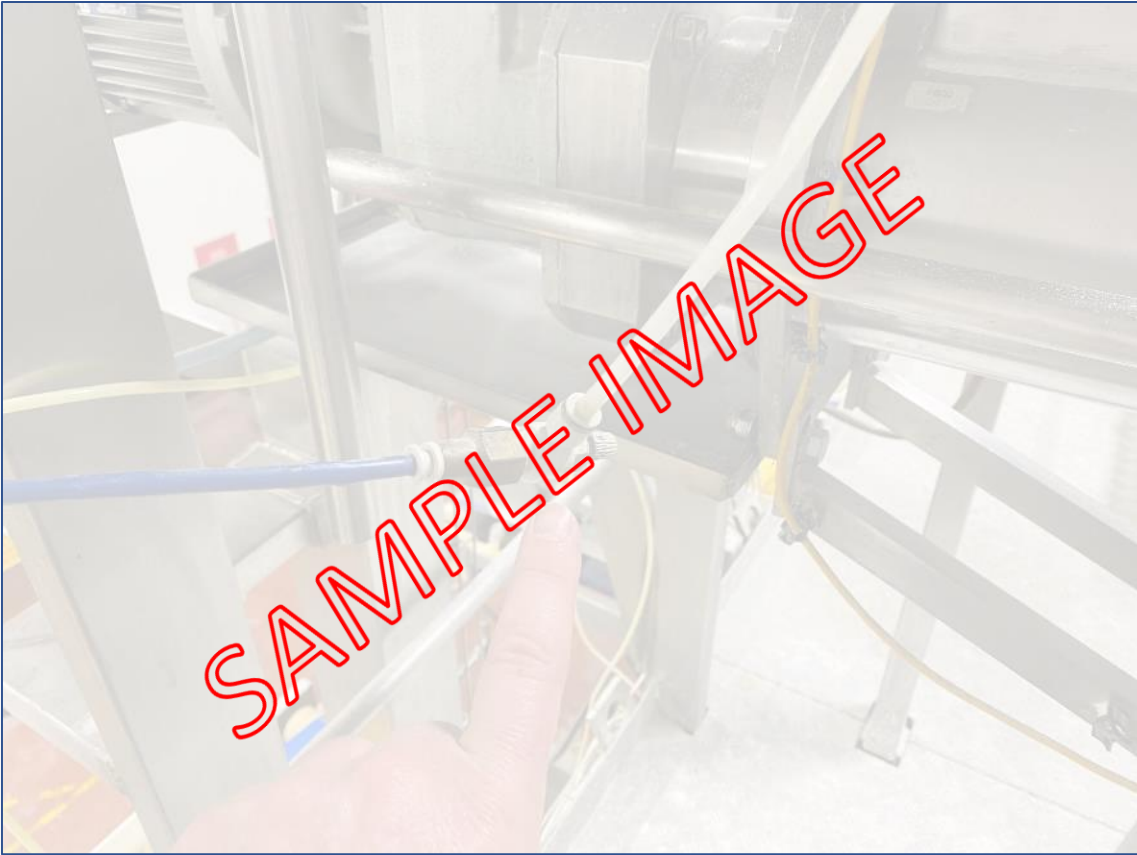
**Leak No.2**

2	Ingredient mezzanine area - Line A premixer fluidiser air supply	Air leaking from threaded connection between brass fitting and flow regulator inlet	1	0.5	88.75

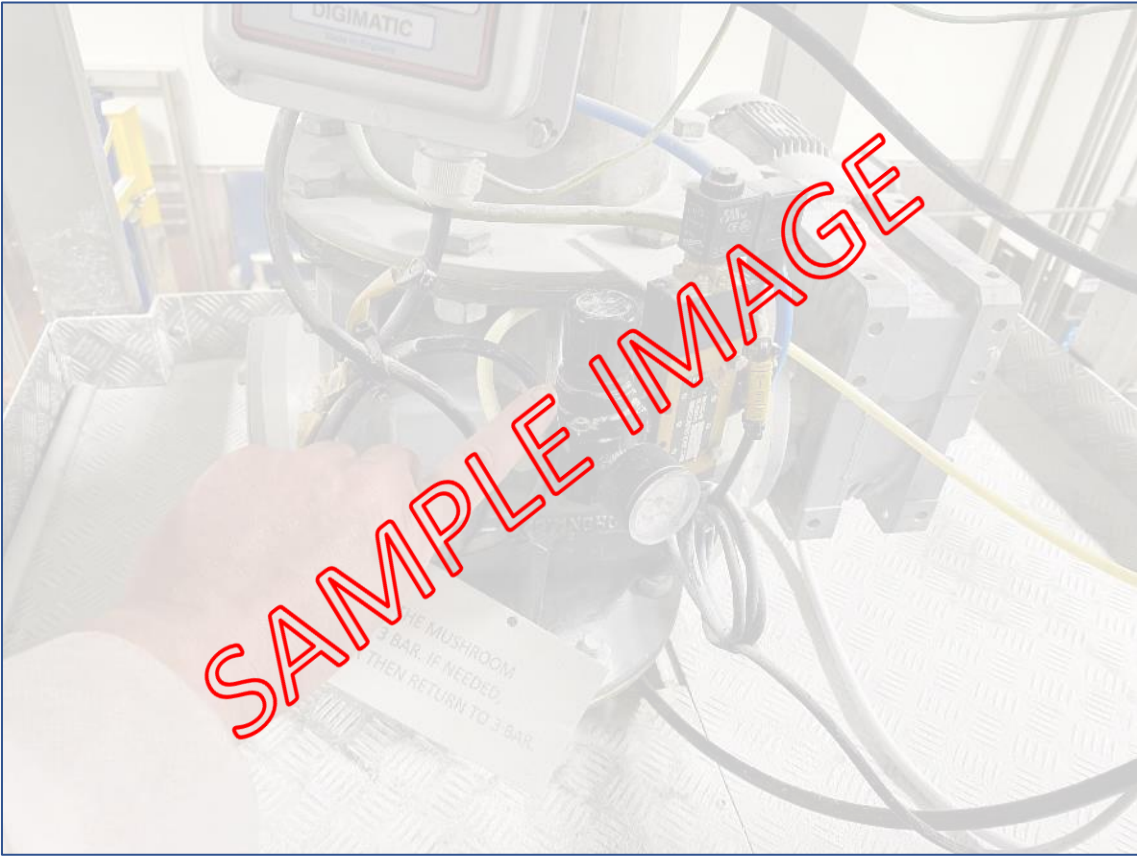
**Leak No.3**

Leak No.	Location of Leak	Nature of Leak (Location, Description)	Severity of Leak (1-10)	Estimated Leak Size (cfm)	Estimated Max Cost (£)	Photo
3	Ingredient mezzanine area upper level - Line B flour hopper fluidiser - Pressure regulator	Air passing from base of adjuster knob	2	1.2	220.93

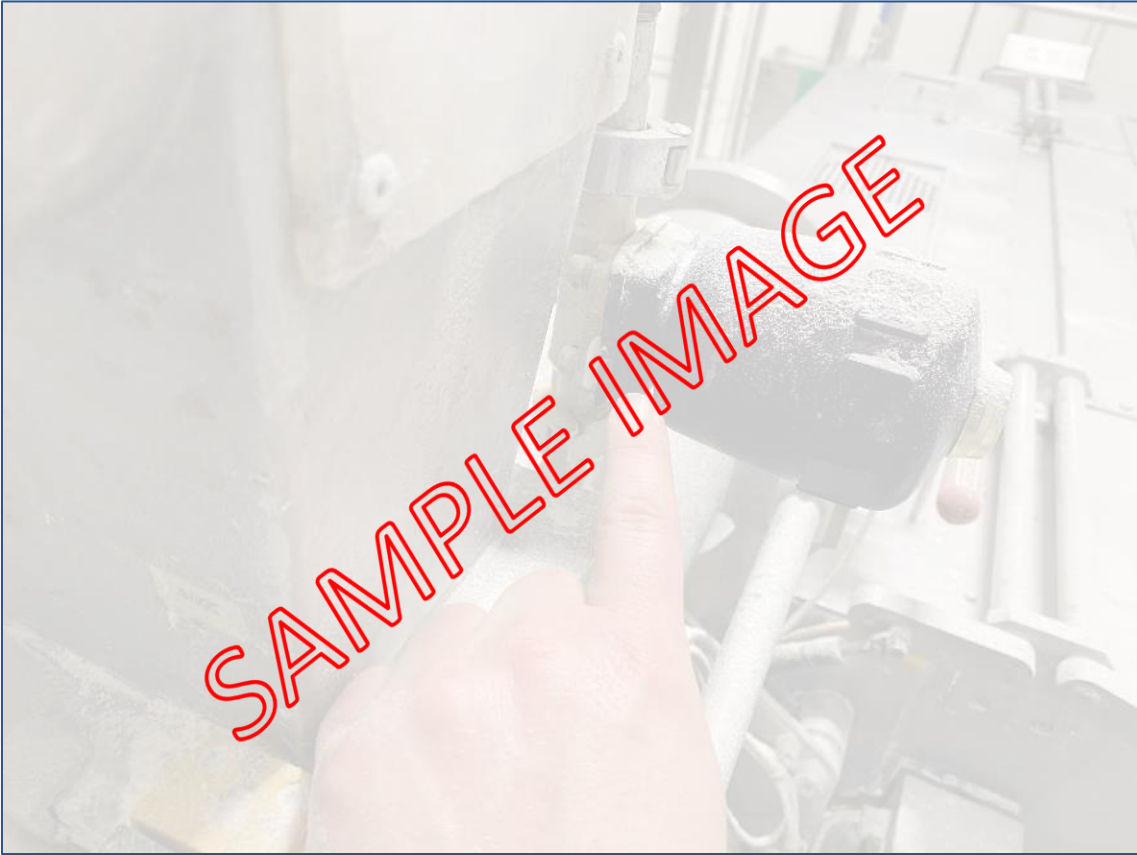
**Leak No.4**

4	Ingredient mezzanine area - premixer egg control valve actuator	Air passing from small port at the base of the actuator when calling egg. Note: the severity of this leak has been de-rated by 85% due to the leak only occurring when egg is calling	1	0.5	88.75

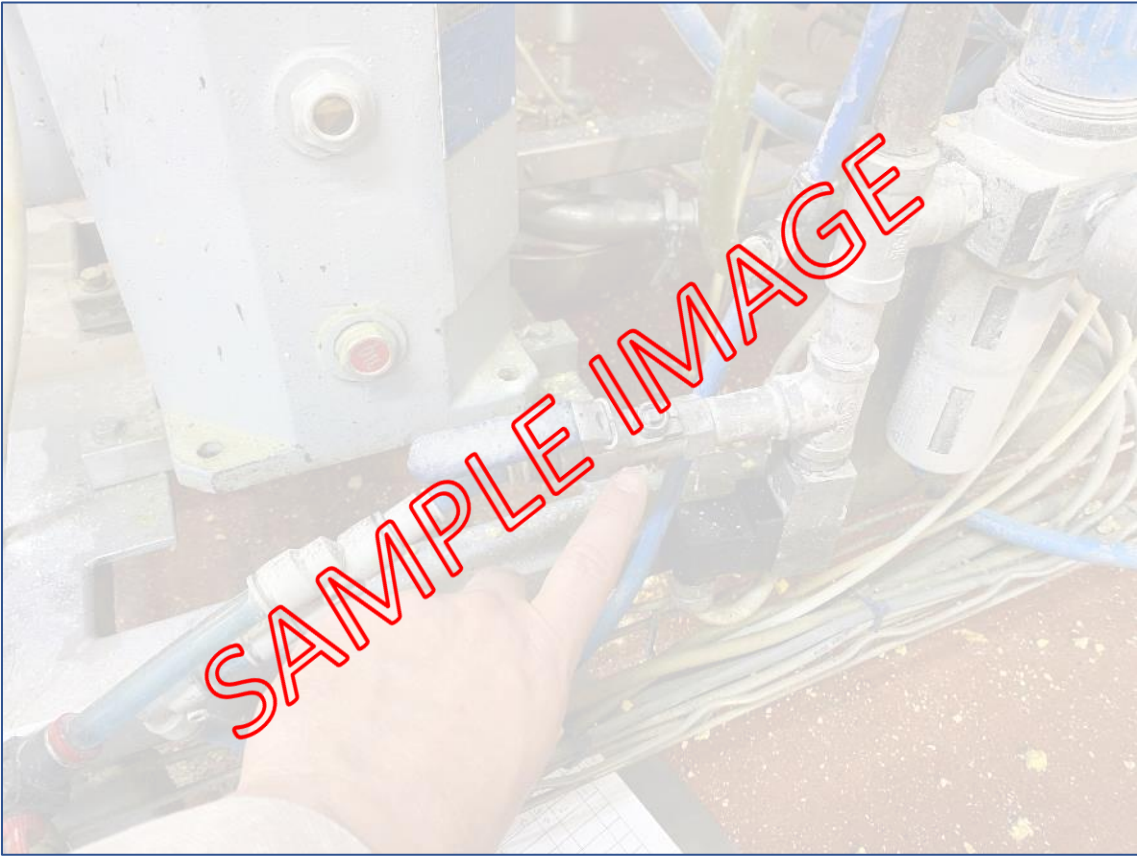
**Leak No.5**

5	Line A Kansui Pump Skid - Hand valve feeding yellow air line hose	Air passing from valve stem seal	1	0.5	88.75

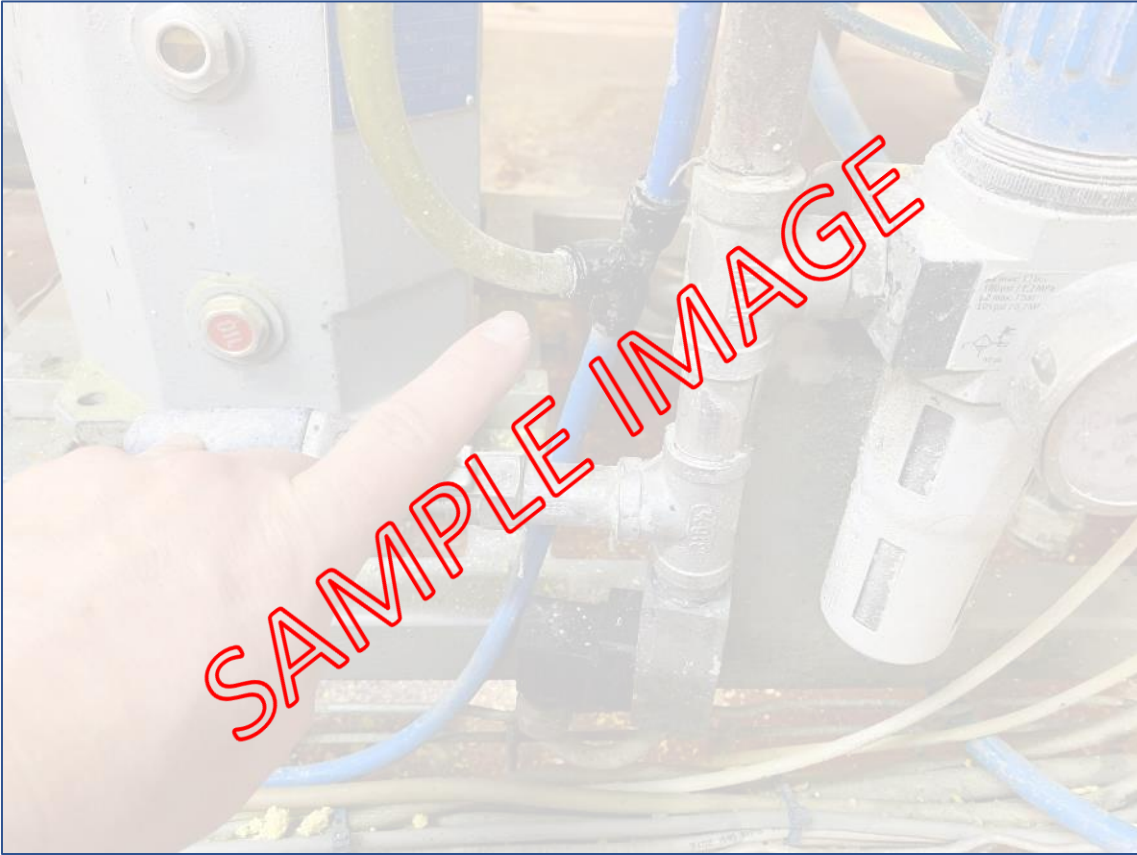
**Leak No.6**

6	Line A Kansui Pump Skid - Air pipework	Air leaking from connection between push-fit tee fitting and clear air pipe	3	1.8	330.45

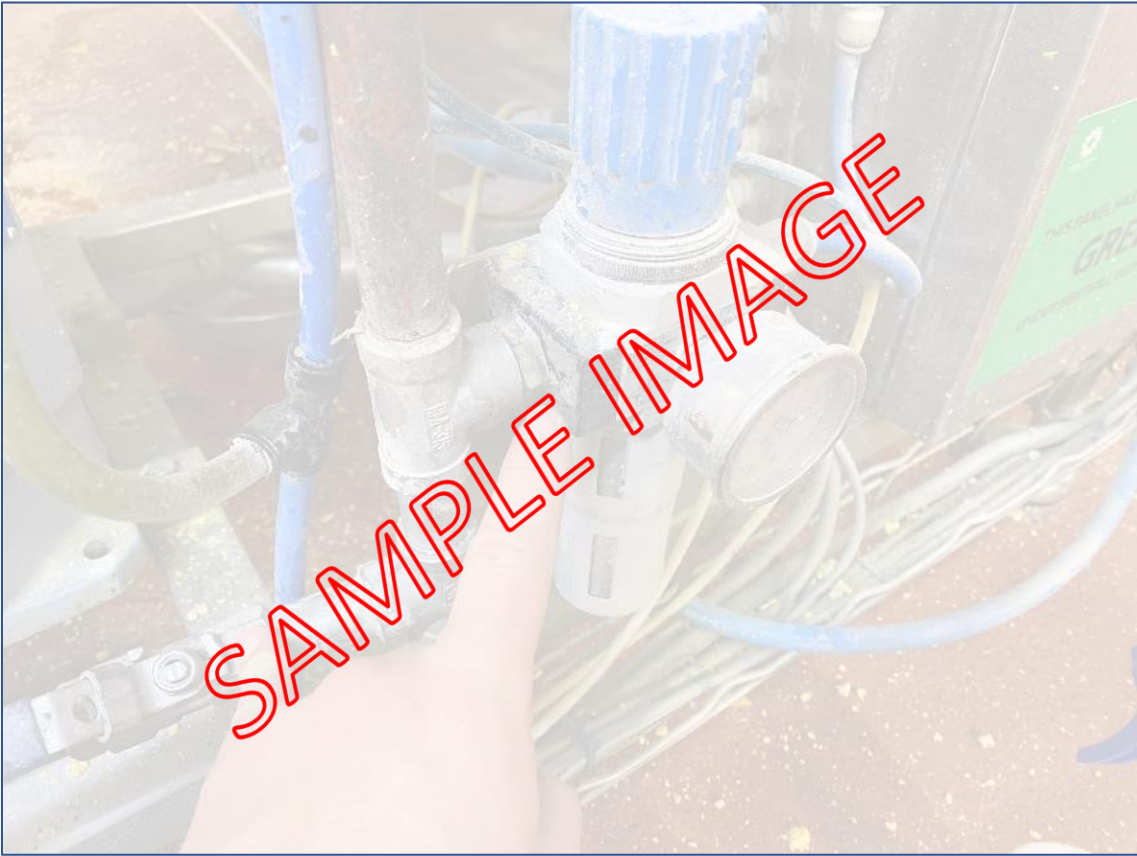
**Leak No.7**

7	Line A Kansui Pump Skid - Pressure Regulator	Air leaking from connection into inlet manifold	2	1.2	220.93

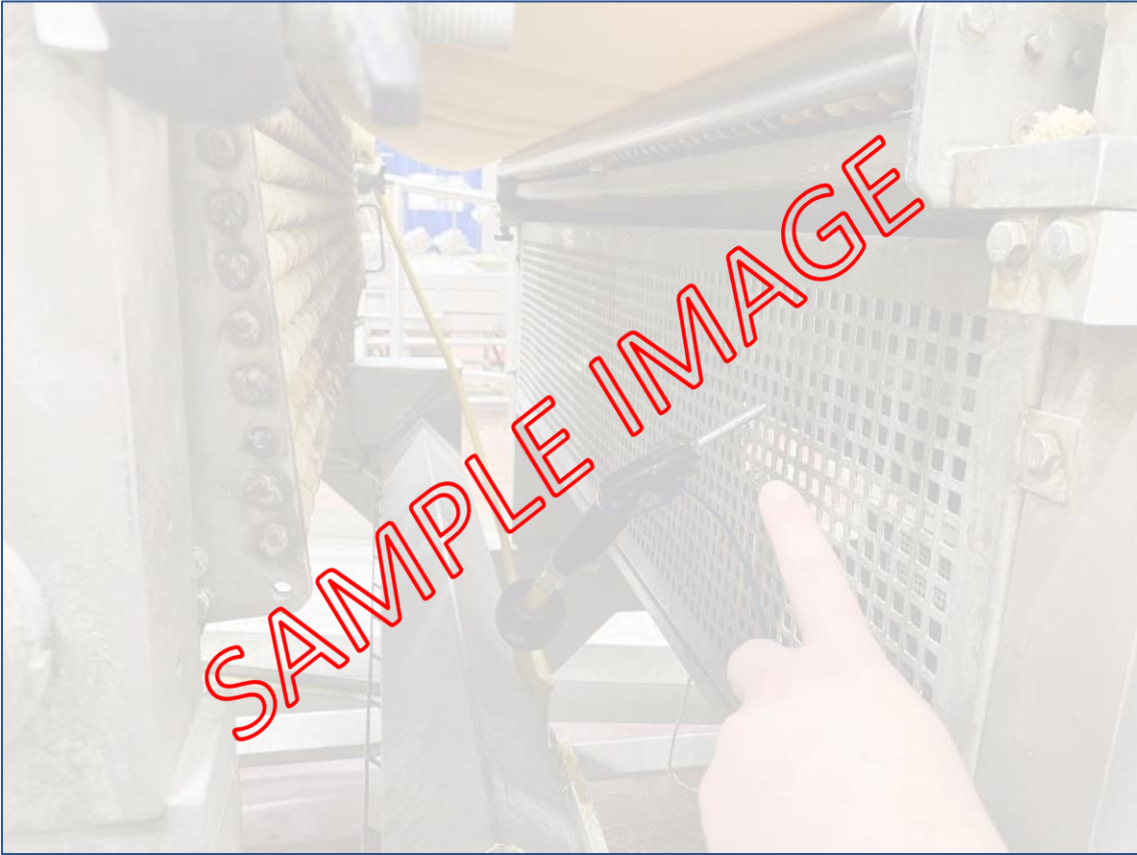
**Leak No.8**

Inappropriate use of compressed air (Using air hose lines to blow onto the product sheet) account for around 35% (approx. £9k) of the losses.

8	Line A calibration roller 5 - Air gun hose line	Improper use of compressed air line to blow air onto product sheet (2.5 - 3mm open end)	8	17.5	3304.47

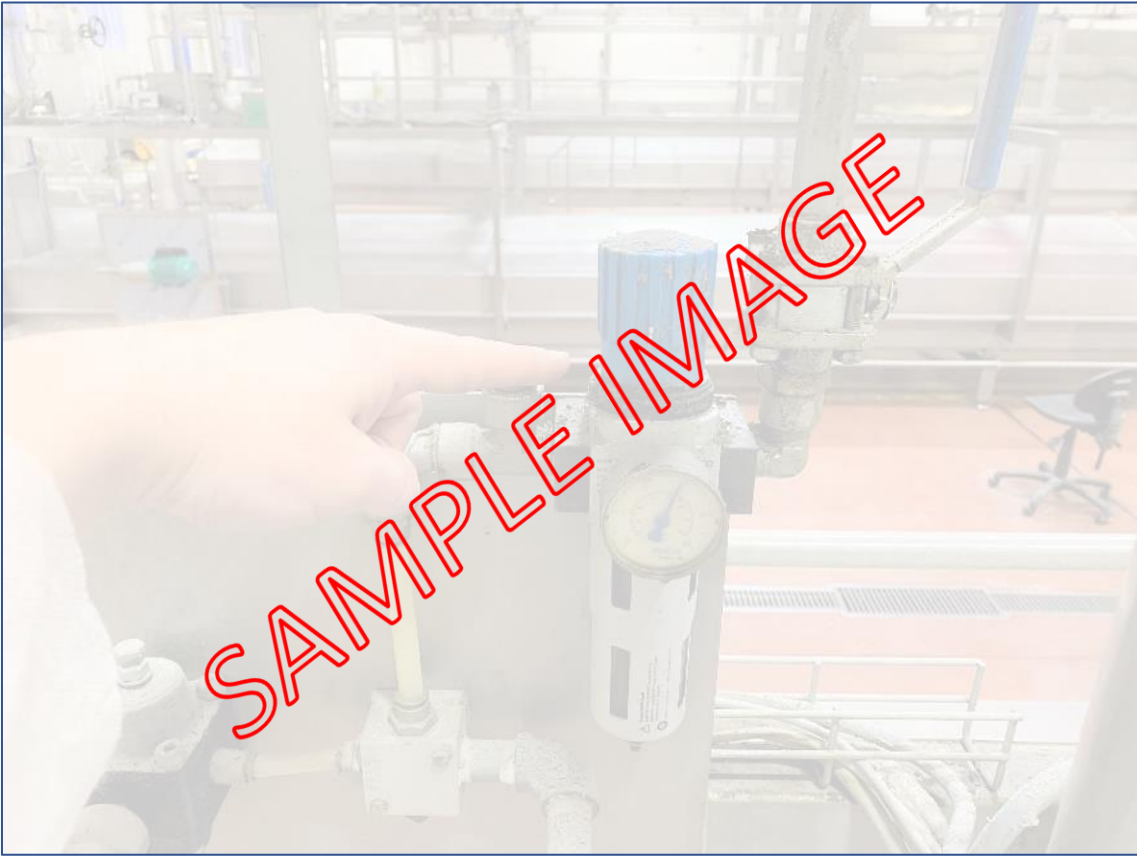
**Leak No.9**

9	Line A Pasteuriser - Infeed end steam system air supply - Pressure Regulator	Air passing from base of adjuster knob	1	0.5	88.75

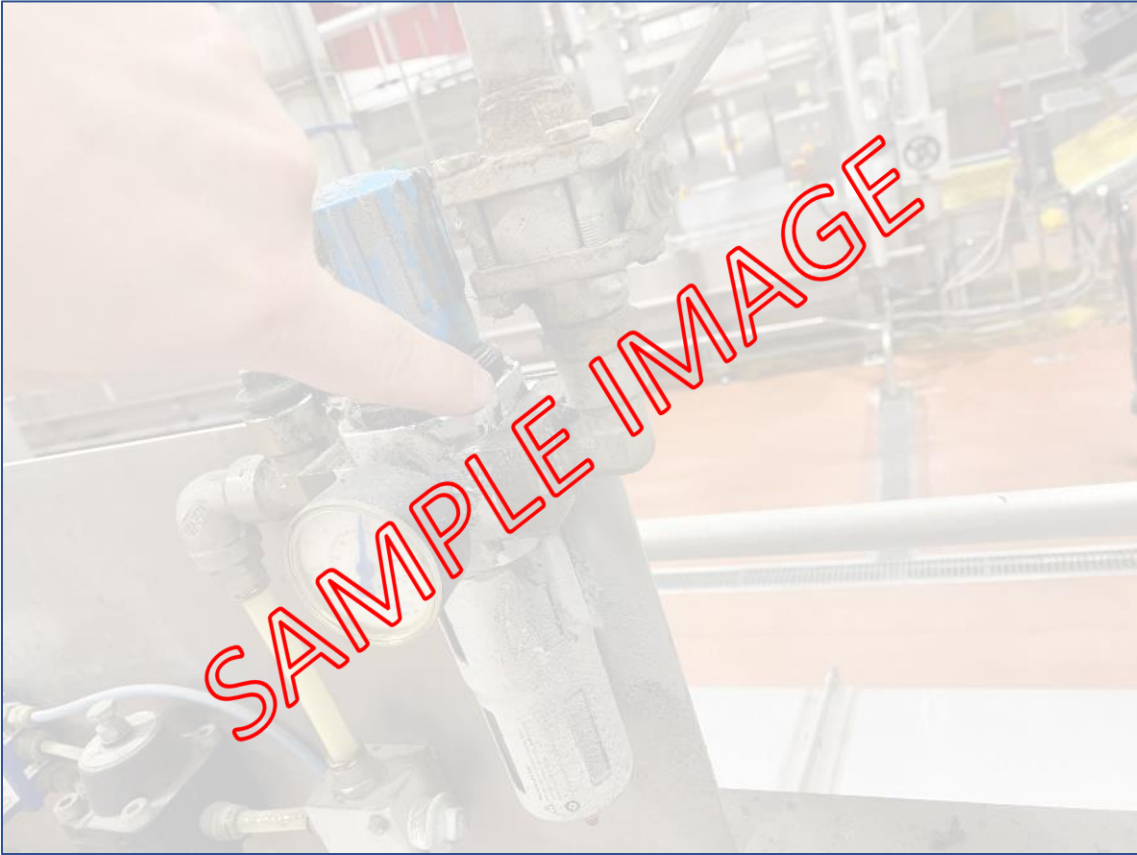
**Leak No.10**

10	Line A Pasteuriser - Outfeed end steam system air supply - Pressure Regulator	Leak from joint between black inlet block and aluminium regulator body	5	4.7	879.93

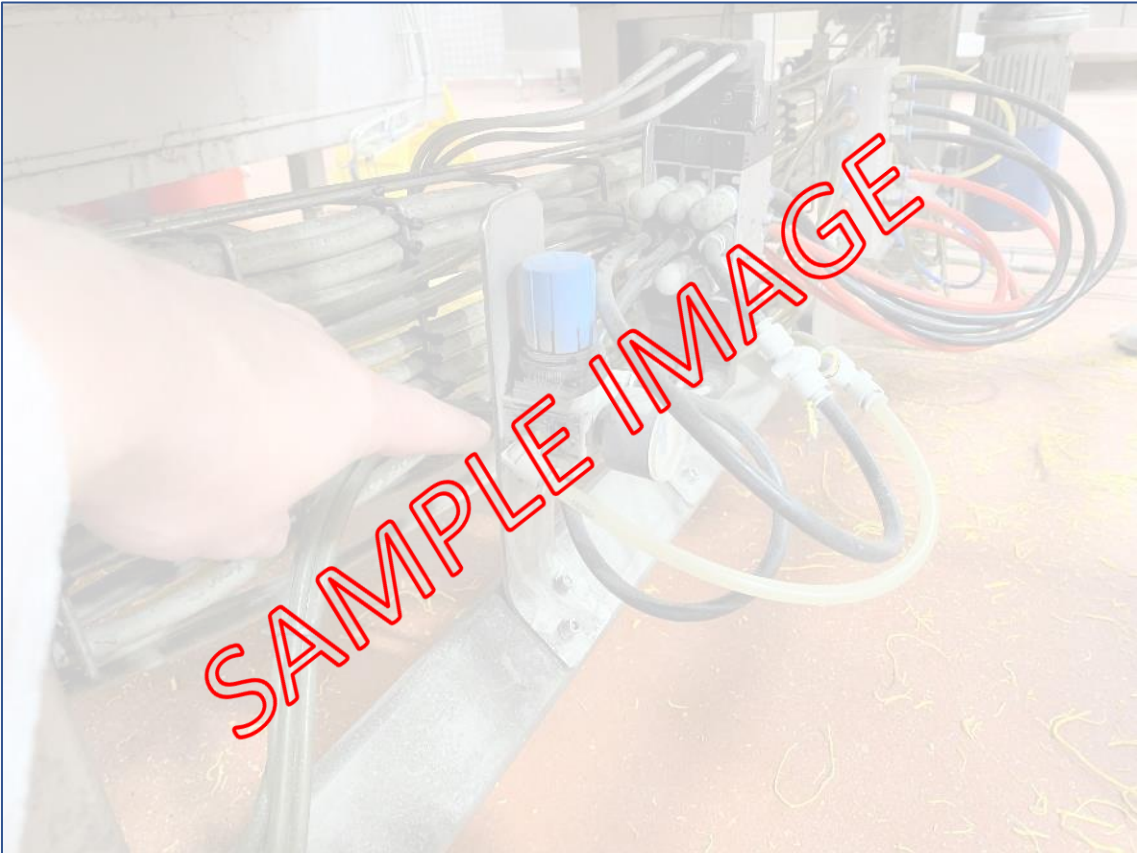
**Leak No.11**

Leak No.	Location of Leak	Nature of Leak (Location, Description)	Severity of Leak (1-10)	Estimated Leak Size (cfm)	Estimated Max Cost (£)	Photo
11	Line A Nester - Air system under cutter	Leak from threaded connection on pressure regulator infeed (Clear Pipe)	1	0.5	88.75

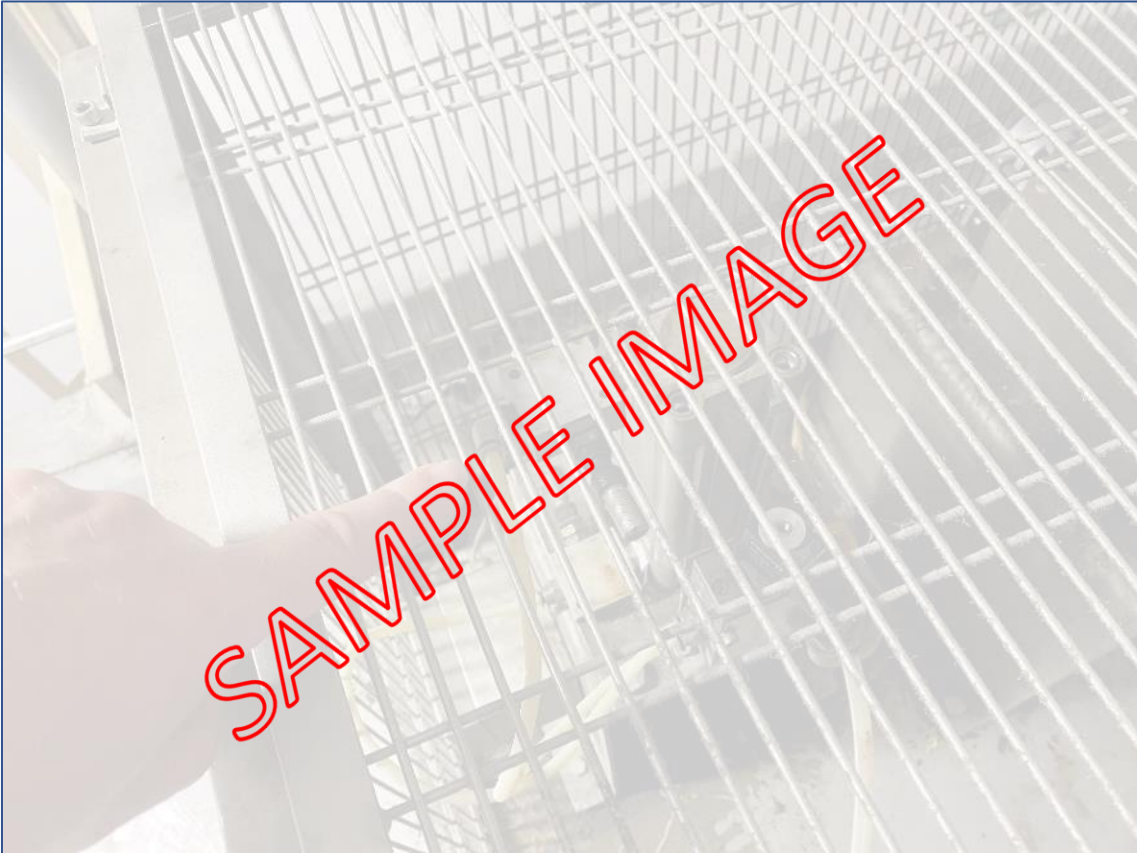
**Leak No.12**

12	Line A Dryer Roof - Loader Flap Cylinder (Wall Side)	Leak from cylinder top push-fit connection into flow regulator	1	0.5	88.75

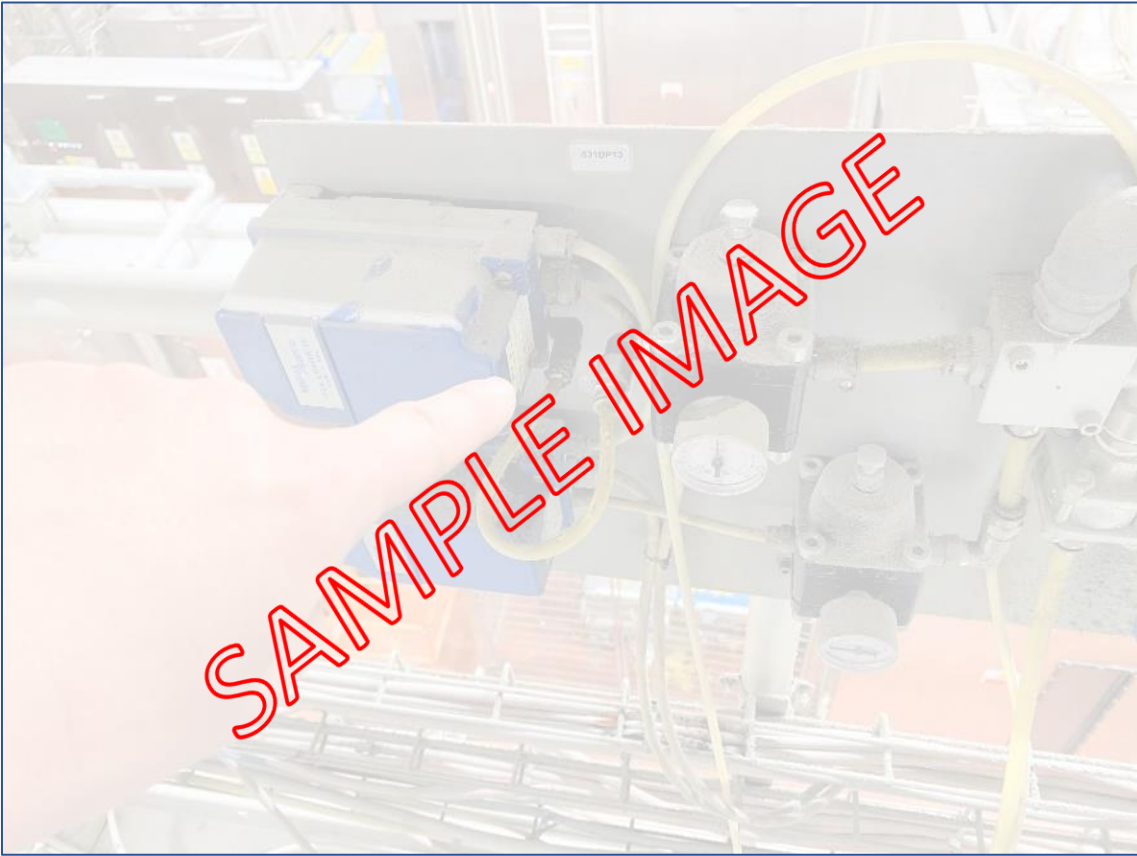
**Leak No.13**

13	Line A Dryer Roof - Air supply set	Leak from push-fit connection into top Spirax Sarco IPC4 converter unit inlet (bottom connection)	1	0.5	88.75

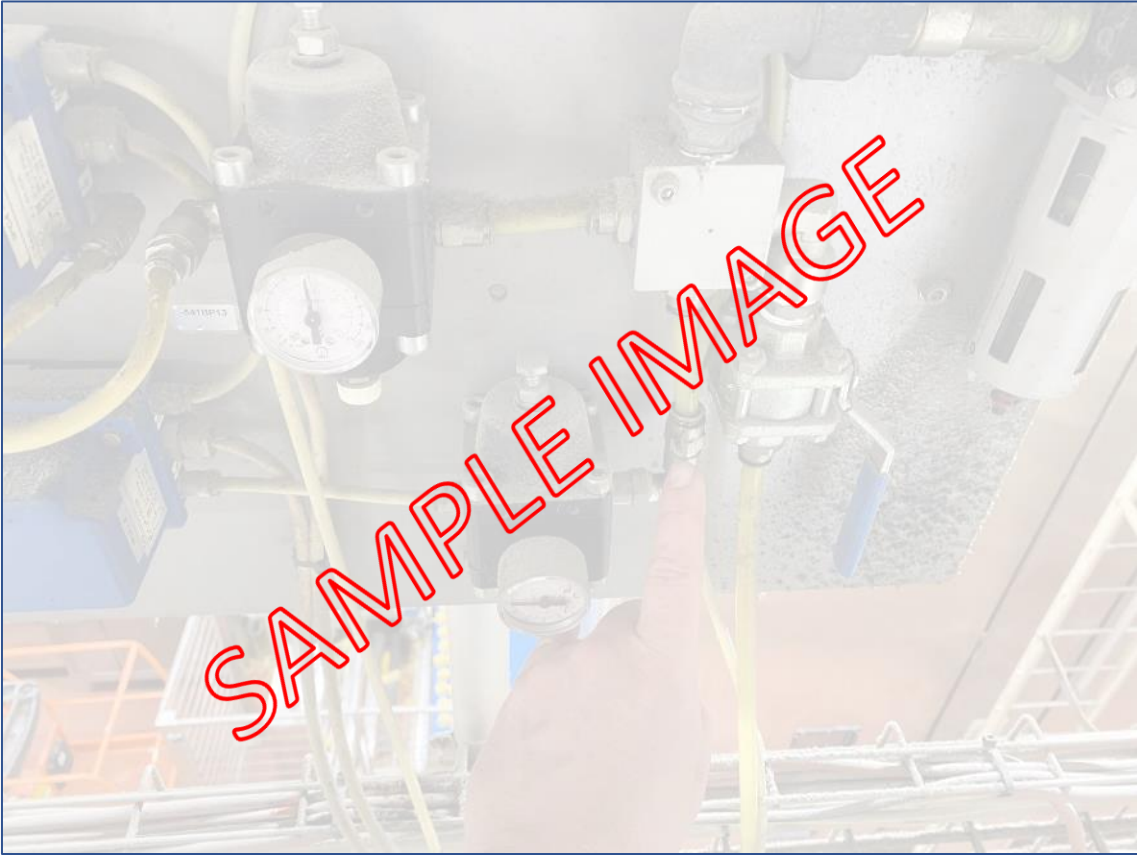
**Leak No.14**

14	Line A Dryer Roof - Air supply set	Leak from push-fit connection into bottom pressure regulator	1	0.5	88.75

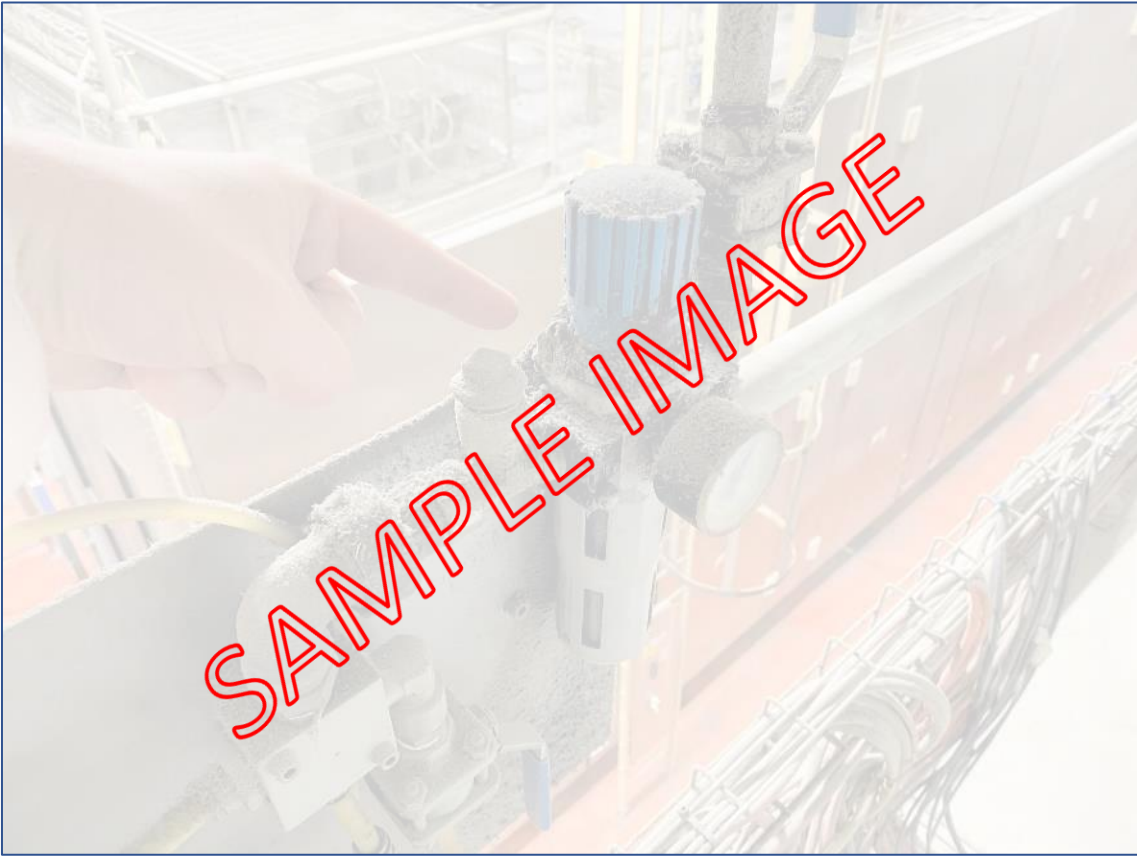
**Leak No.15**

15	Line A Dryer Roof - Air supply set	Air passing from base of adjuster knob	2	1.2	220.93

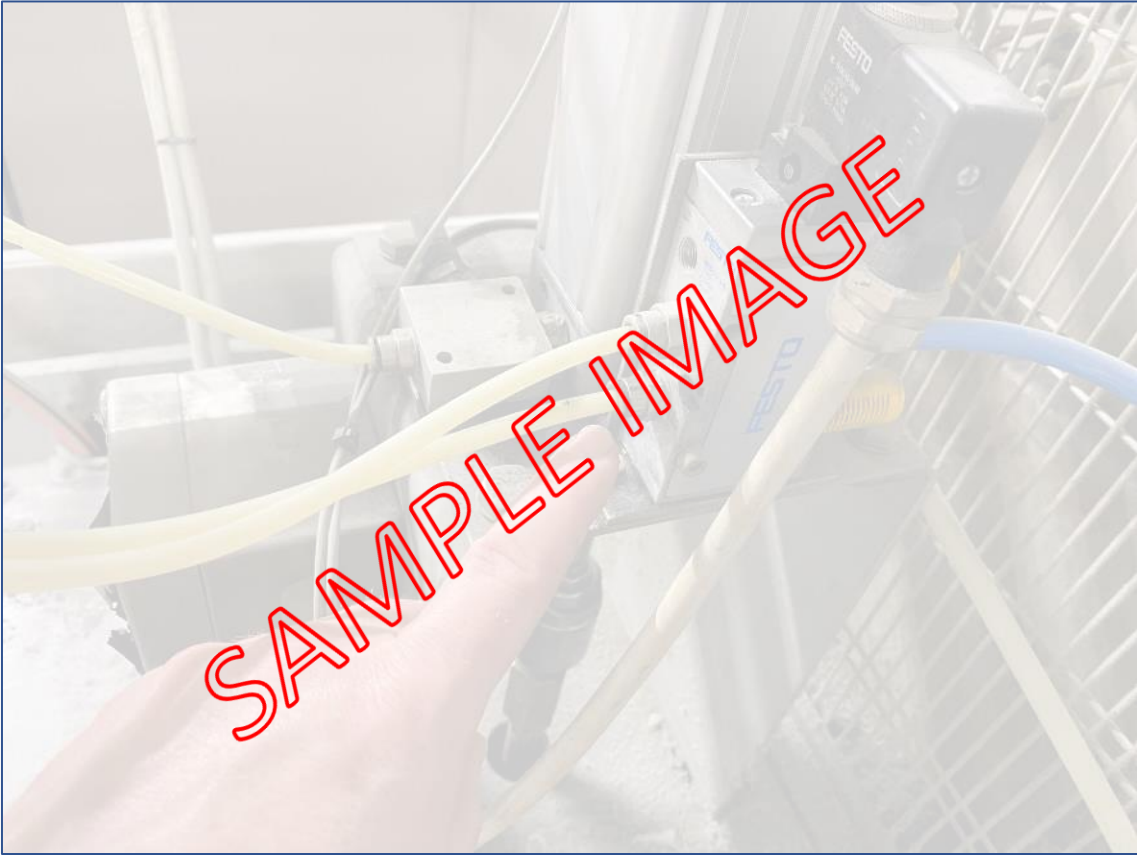
**Leak No.16**

16	Line A Dryer Roof - Unloader flap control valve (Line B side)	Leak from Festo 5 port valve bottom outgoing push fit connection	2	1.2	220.93

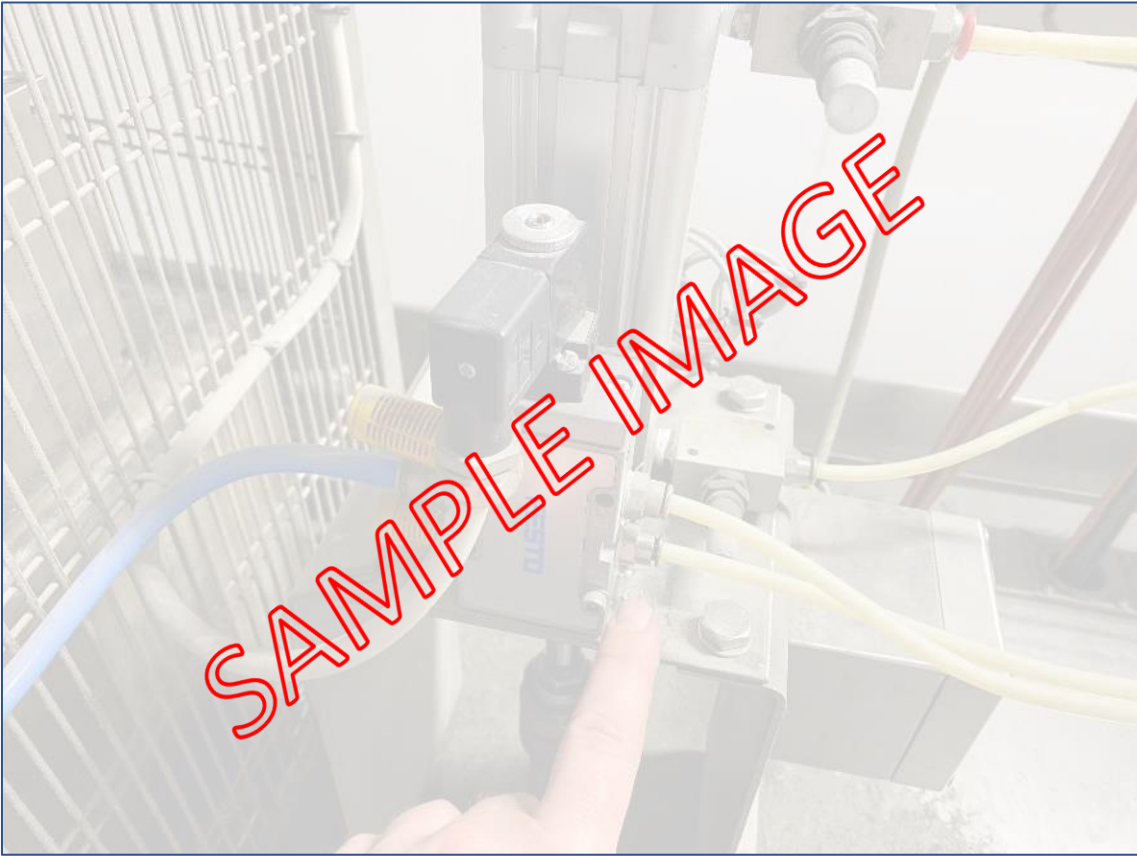
**Leak No.17**

17	Line A Dryer Roof - Unloader flap control valve (Wall side)	Leak from Festo 5 port valve bottom outgoing push fit connection	1	0.5	88.75

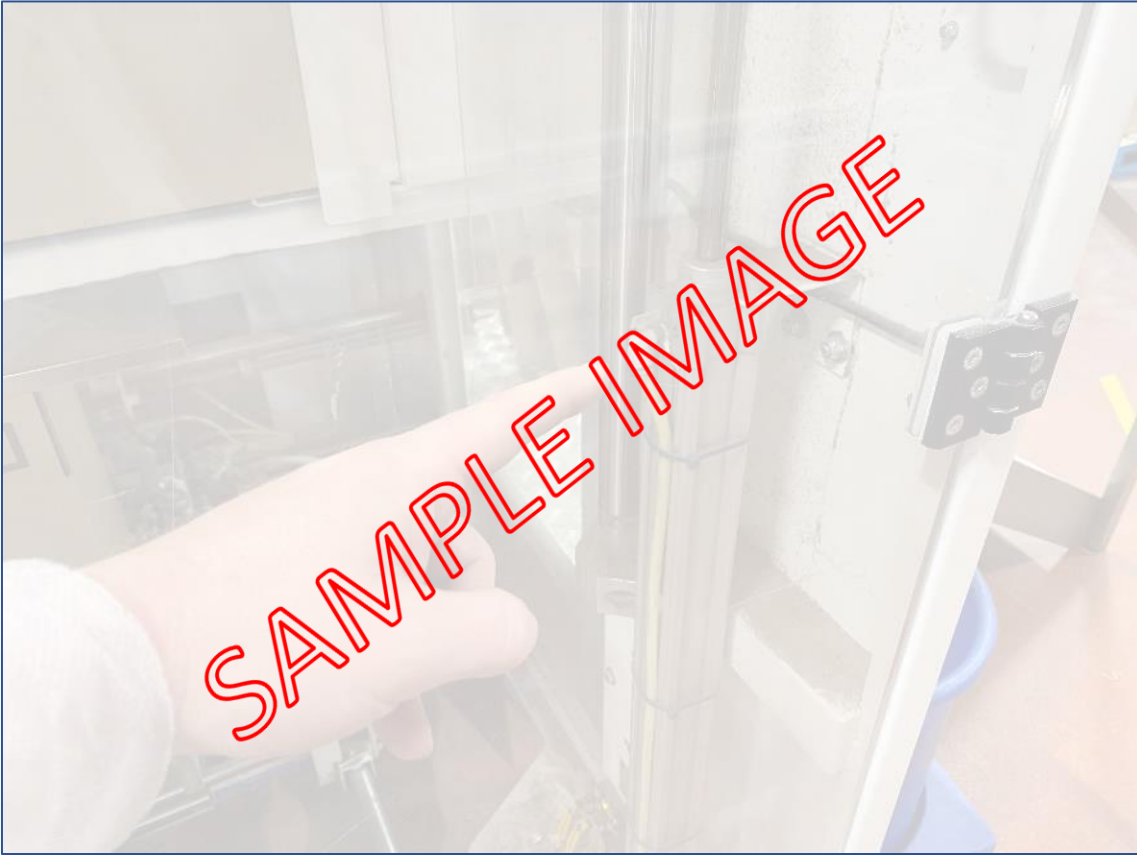
**Leak No.18**

18	Line B Box Erector - Raise lower cylinder	Cylinder top threaded connection (Labelled C15). Note: Leak is behind an interlocked guard so severity is estimated based on the audible noise of the leak	5	4.7	879.93

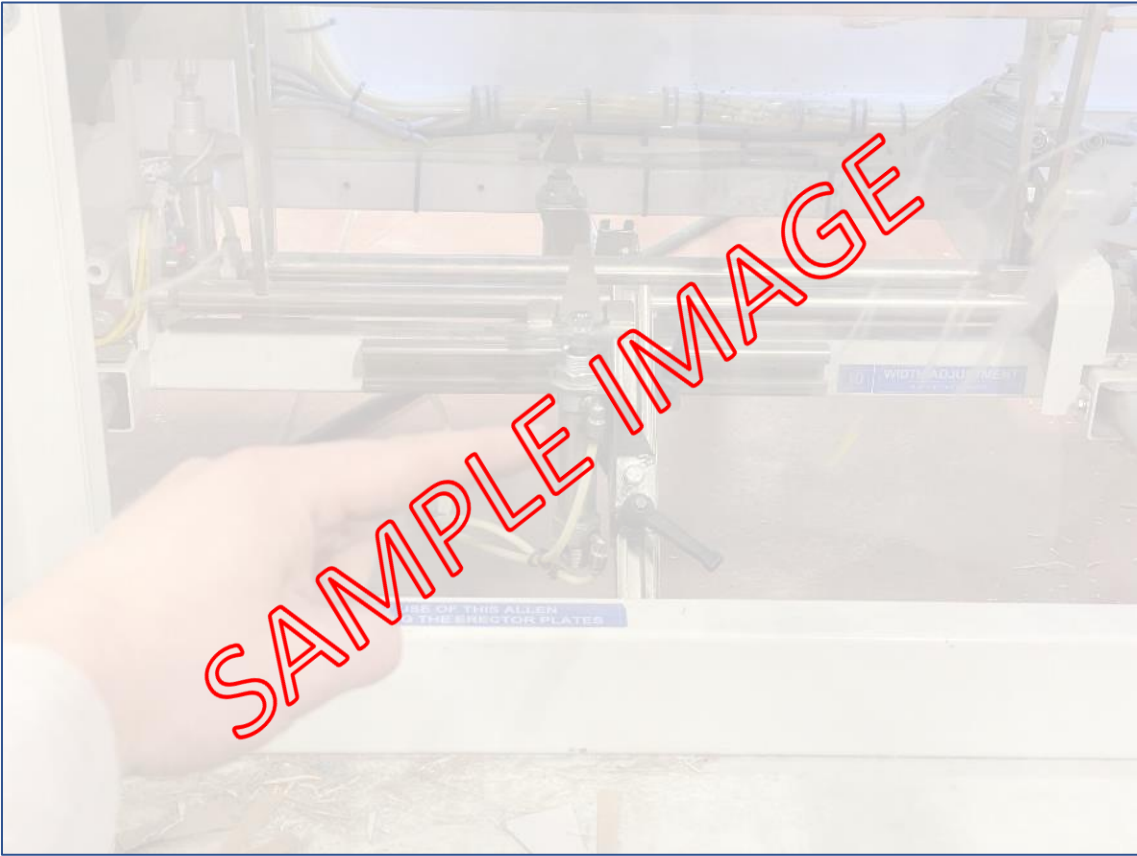
**Leak No.19**

19	Packing Room - Line A Box Erector - Low level flap cylinder - LHS (mixing side)	Leak from cylinder top push-fit connection (Pipe number 14)	5	4.7	879.93

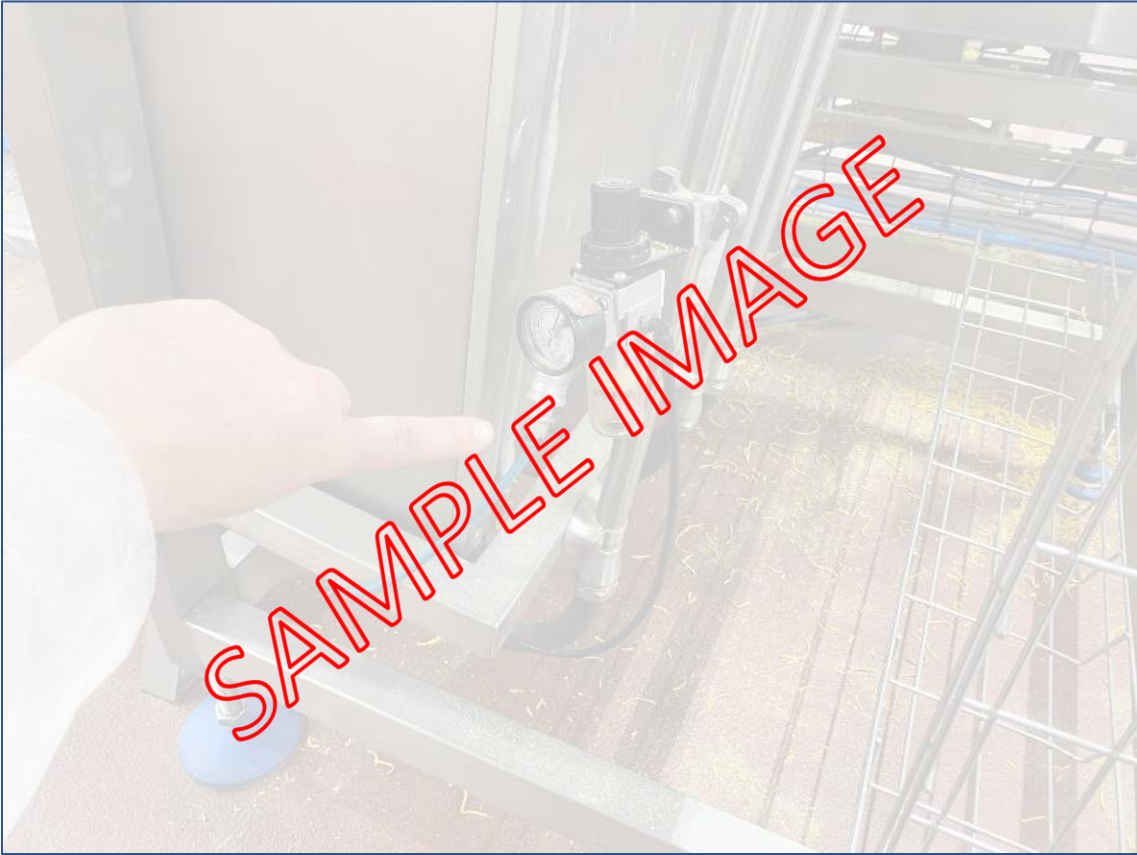
**Leak No.20**

Leak No.	Location of Leak	Nature of Leak (Location, Description)	Severity of Leak (1-10)	Estimated Leak Size (cfm)	Estimated Max Cost (£)	Photo
20	Packing Room - Line A Box Filler - Pressure regulator	Leak from push fit connection on regulator inlet (Blue pipe)	3	1.8	330.45

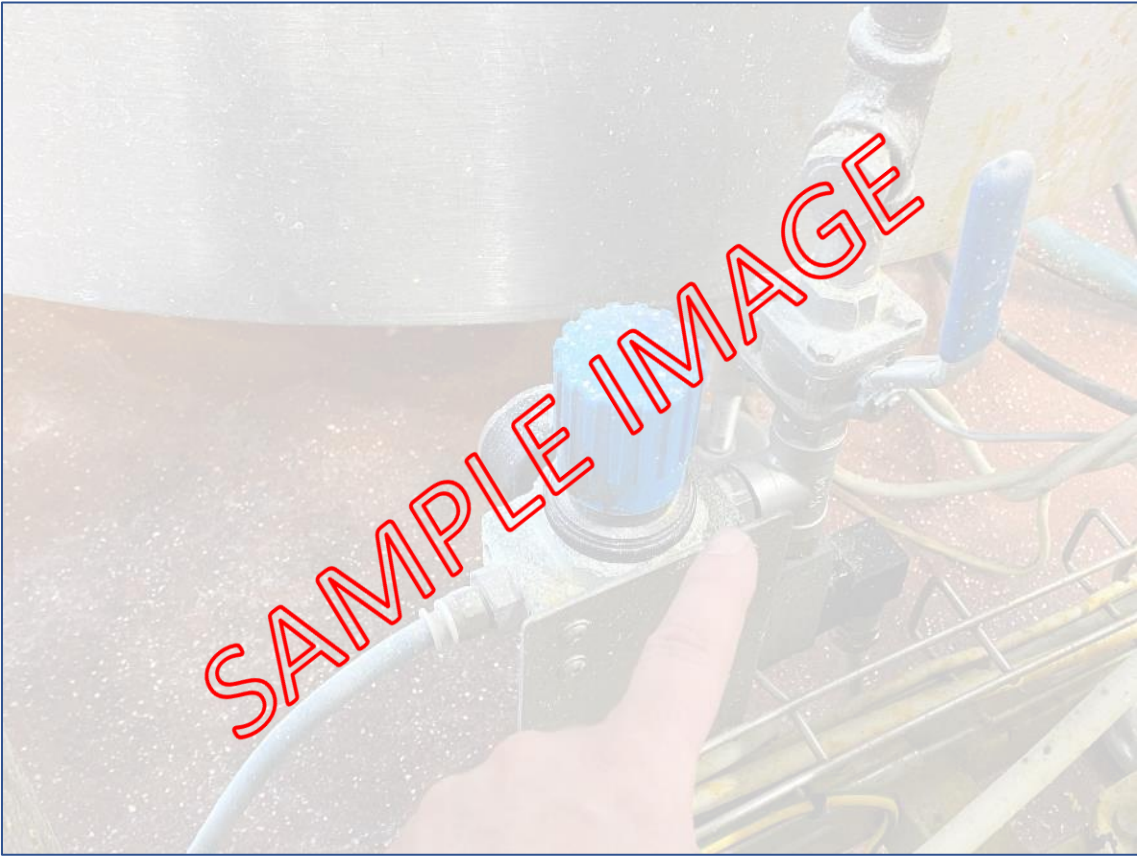
**Leak No.21**

21	Line B Kansui pump skid - Air supply system	Leak from threaded connection between stainless steel tee and air regulator unit	1	0.5	88.75

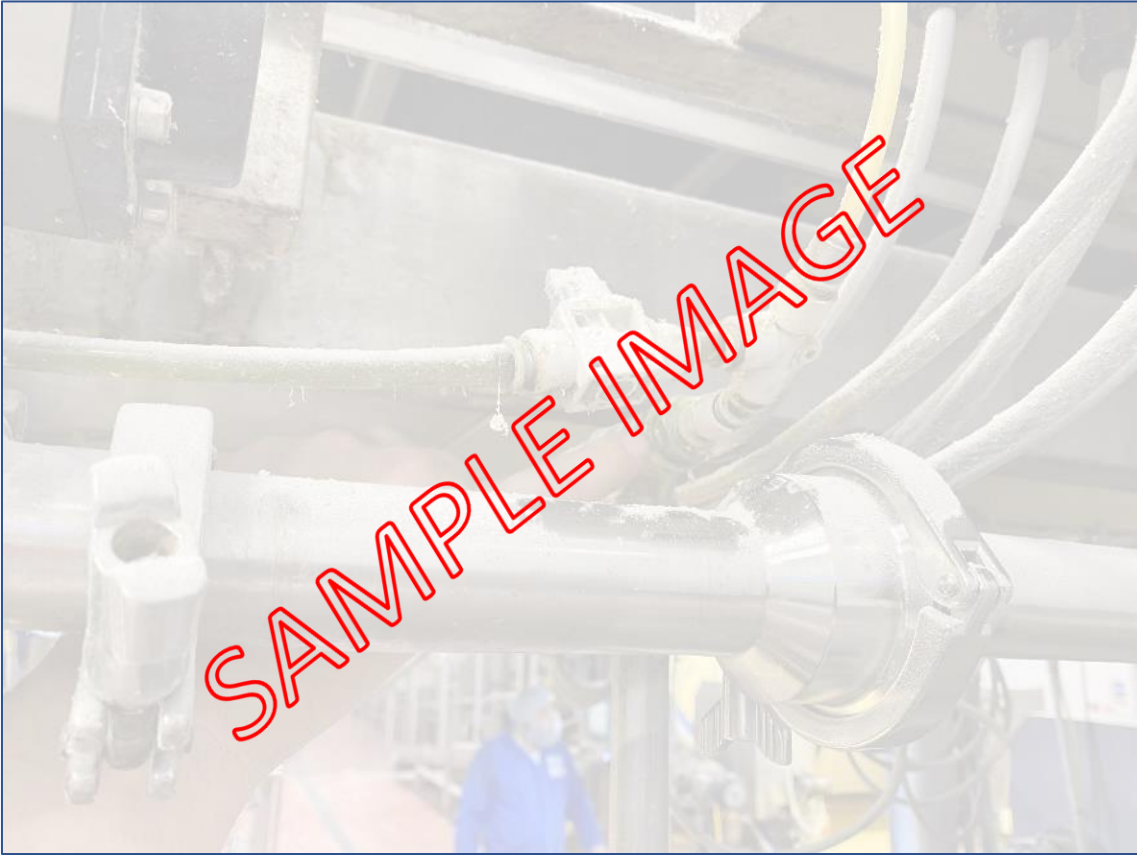
**Leak No.22**

22	Line B - Air pipework above Kansui tank	Leak from threaded connection on stainless steel tee (leg feeding push-fit fittings)	1	0.5	88.75
