# COMPRESSED AIR LEAK DETECTION SURVEY

**September 2020**

The survey was carried out at **On Line Vibration Monitoring Ltd on the 17<sup>th</sup> & 18<sup>th</sup> September 2020** using an ultrasonic leak detection instrument. Digital images of leak sites were taken for positive identification purposes. The whole site was surveyed including production plants, distribution systems and services.

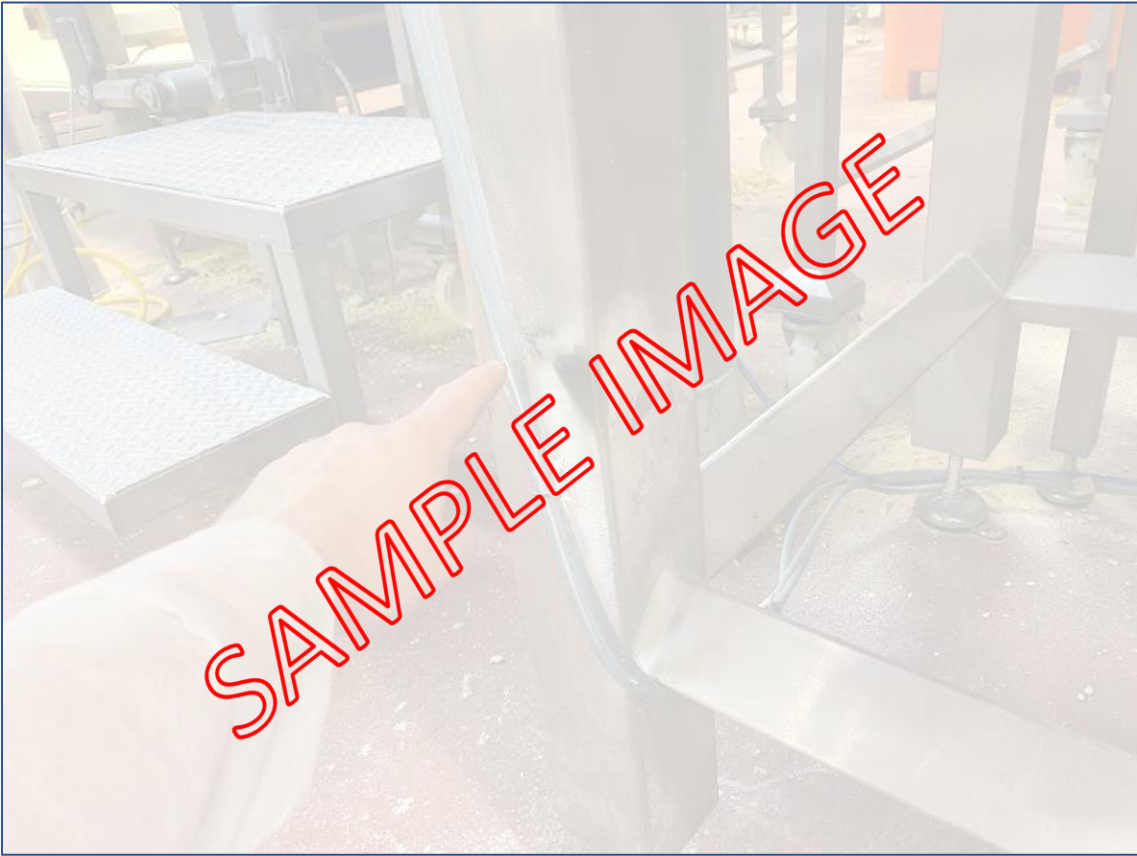
**Leak No.23**

23	Line B - Low level pipework on calibration roller platform leg (Line A side) adjacent to HMI panel	Leak from hole in airline	4	2.9	551.38

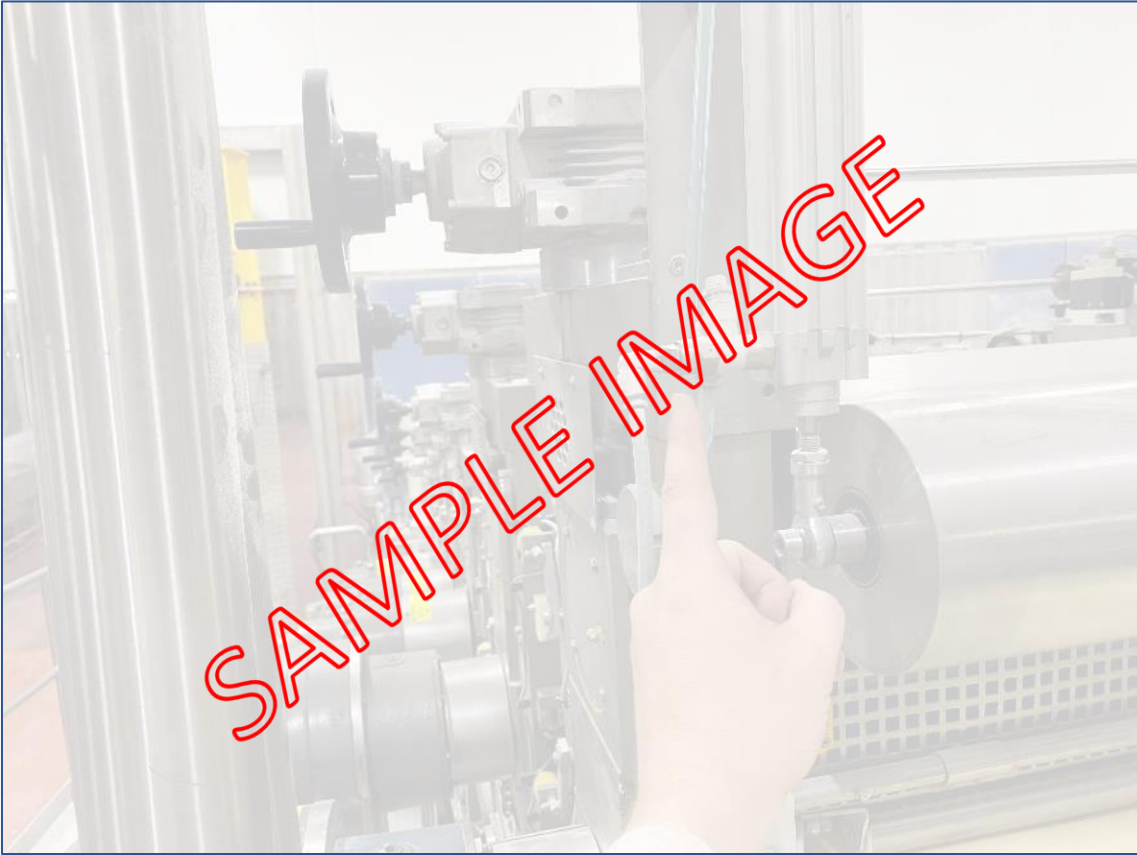
**Leak No.24**

24	Line B - Calibration roller 1 - Infeed top roller raise / lower cylinder (Line C side)	Air leaking from cylinder bottom 90 degree fitting	3	1.8	330.45

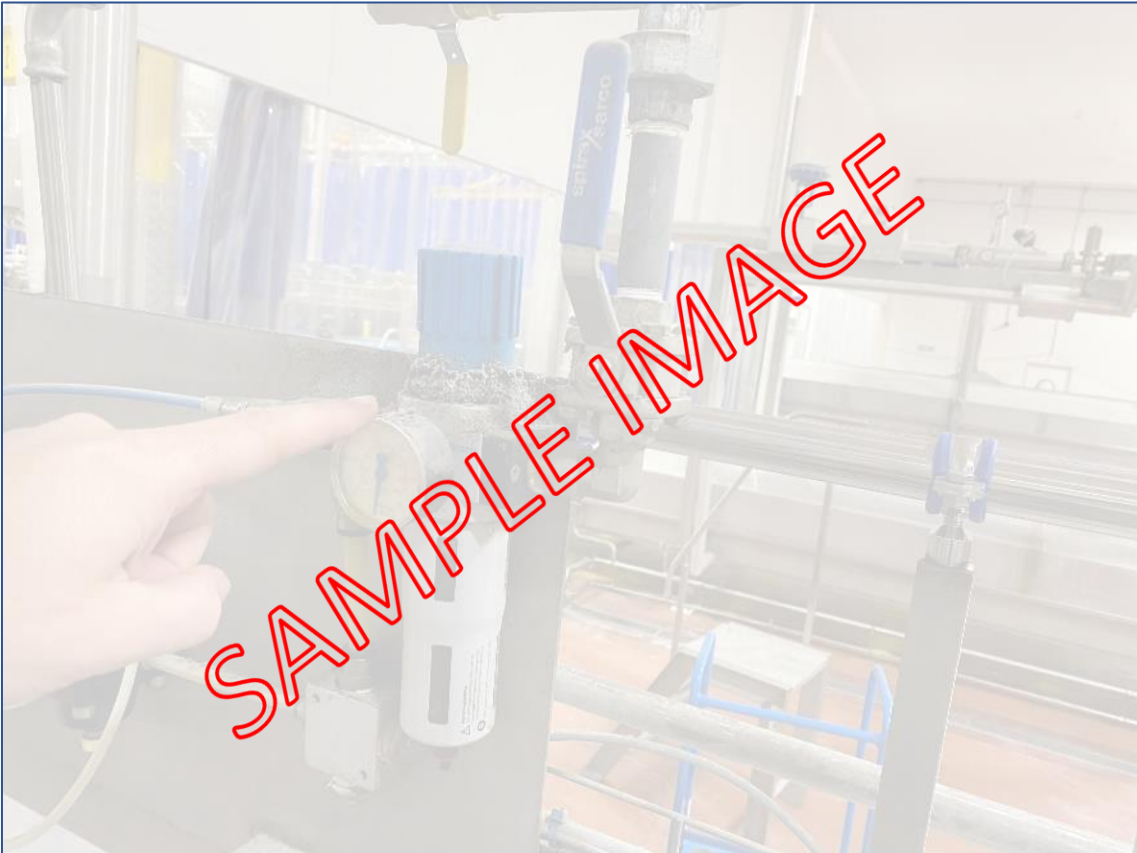
**Leak No.25**

25	Line B Pasteuriser - Infeed end steam system air supply - Pressure Regulator	Air passing from base of adjuster knob	2	1.2	220.93

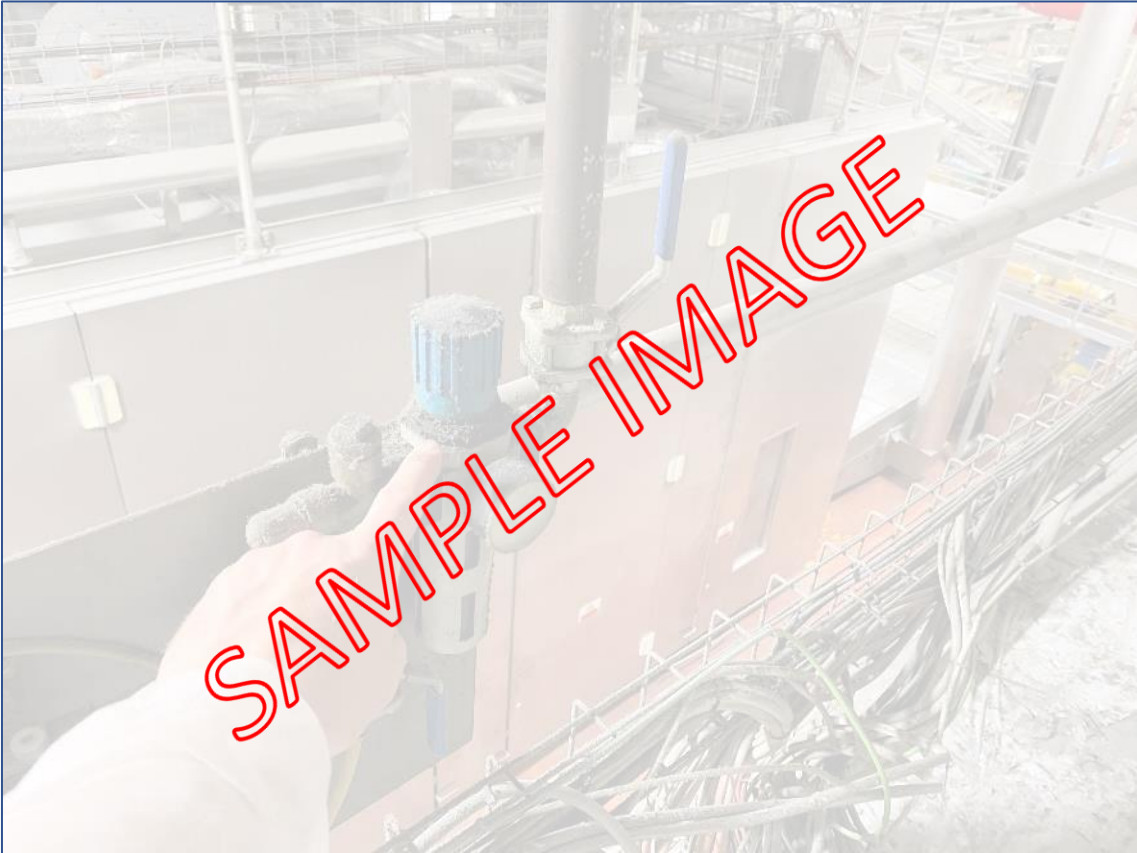
**Leak No.26**

Leak No.	Location of Leak	Nature of Leak (Location, Description)	Severity of Leak (1-10)	Estimated Leak Size (cfm)	Estimated Max Cost (£)	Photo
26	Line B Dryer Roof - Air supply set	Air passing from base of adjuster knob	2	1.2	220.93	 
27	Line B Dryer Roof - Air supply set	Air leaking from bottom pressure regulator inlet push-fit connection	1	0.5	88.75	 
28	Line B Dryer Roof - Air supply set	Leak from push-fit connection into top Spirax Sarco IPC4 converter unit inlet (bottom connection)	2	1.2	220.93	 
29	Packing Room - Line B box closer machine	Leak from split in clear blue airline feeding first bag lift cylinder on RHS	5	4.7	879.93

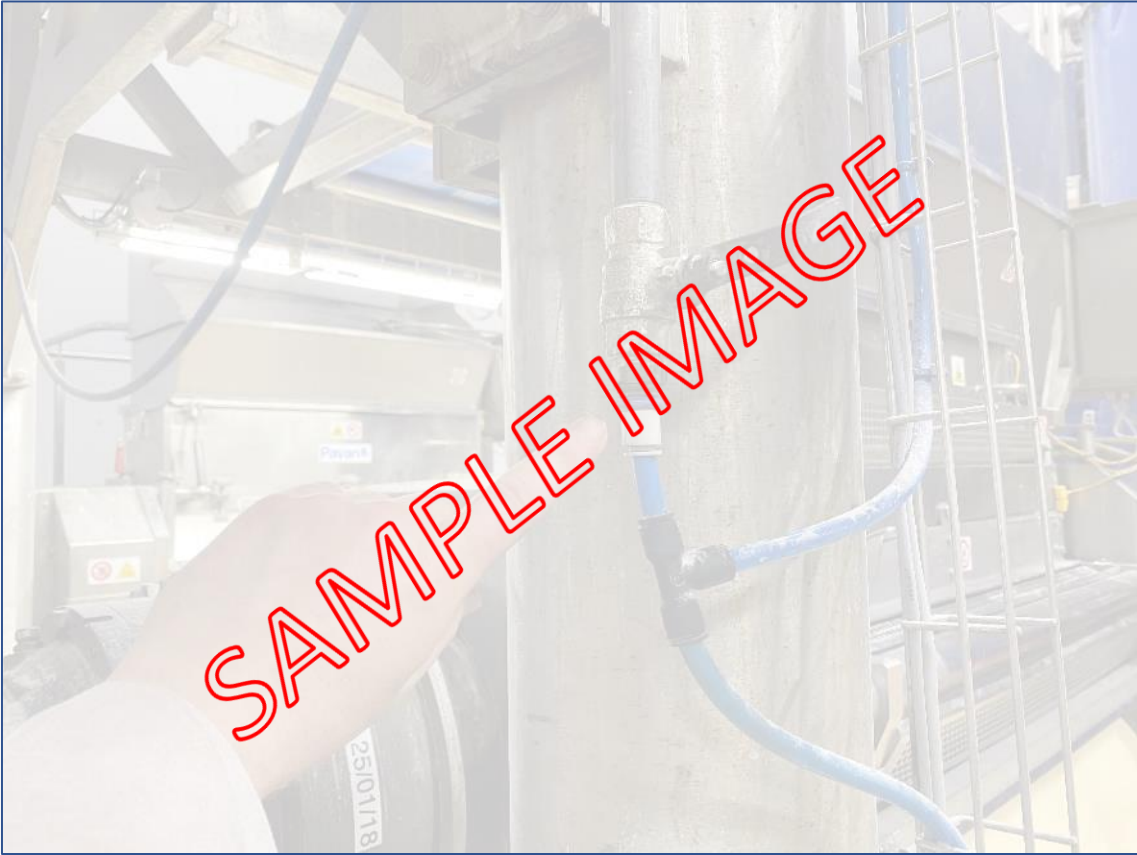
**Leak No.30**

Leak No.	Location of Leak	Nature of Leak (Location, Description)	Severity of Leak (1-10)	Estimated Leak Size (cfm)	Estimated Max Cost (£)	Photo
30	Line C - Air line feeding air hose reel adjacent to kneader sheeter 2 (Line B side)	Leak from isolation hand valve bottom push-fit connection	1	0.5	88.75
