# VIBRATION SURVEY

**Sample Vibration Monitoring Report**

September 2020

1. Vibration monitoring of machinery and equipment in the **Bread Plants, Morning Goods Plant & Services** was carried out between the **24<sup>th</sup> & 28<sup>th</sup> August 2020** on behalf of **On Line Vibration Monitoring Ltd, Cumbria**.

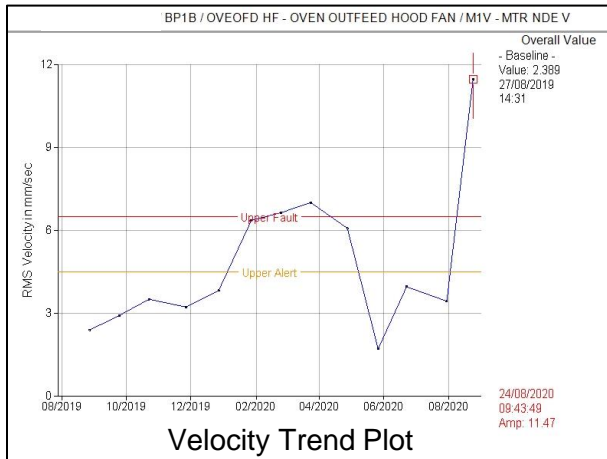
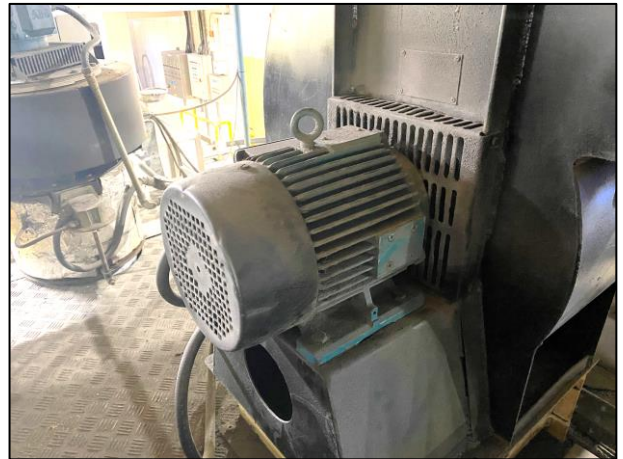
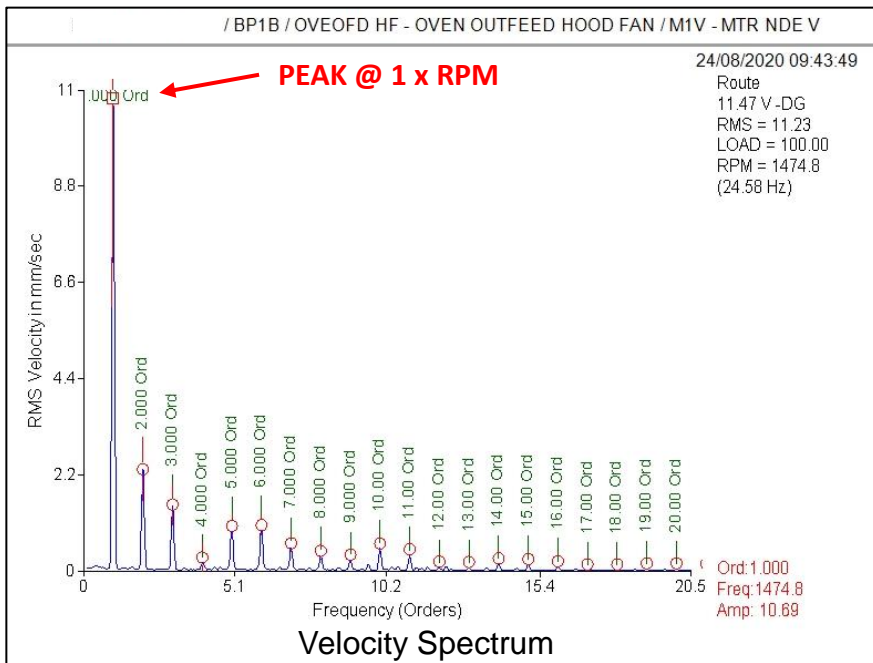
## BP 1 OVEN – OUTFEED HOOD FAN

Vibration velocity measured on the outfeed hood fan motor has increased above alarm level 2 this visit. The velocity spectrum shows a peak relating to 1 x running speed with a series of harmonics. High frequency vibration is low indicating serviceable bearing condition. The increase in vibration and the patterns in the spectrum may be due to a combination of fan imbalance and developing looseness.

**Investigate:** - Inspect / clean the fan impeller. Check for damage, eccentricity, security etc. Also check the motor and fan housing fixing bolts are secure.

**Investigate: - Inspect / clean the fan impeller. Check for damage, eccentricity, security etc. Also check the motor and fan housing fixing bolts are secure.**

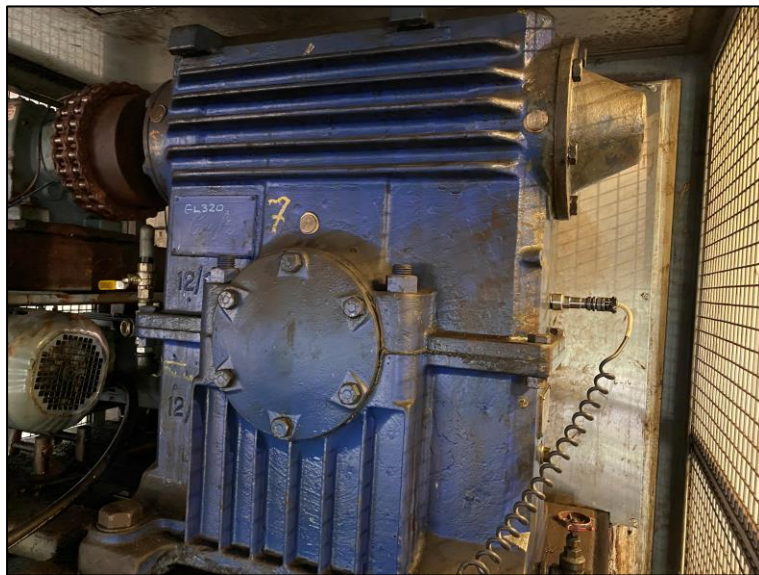
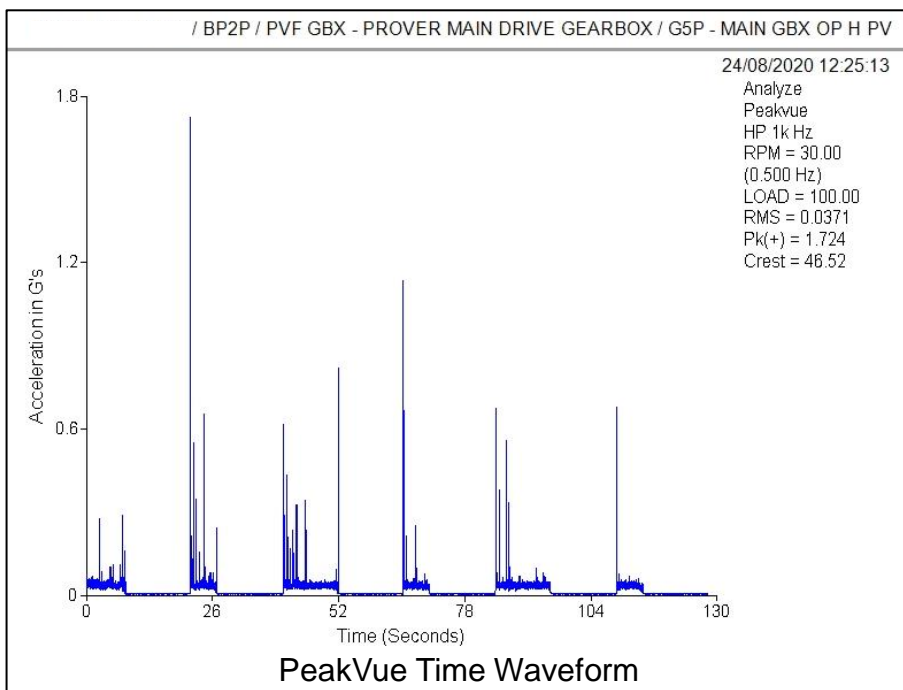
## BP 2 FINAL PROVER – MAIN DRIVE GEARBOX

The PeakVue time waveform recorded on the main gearbox output shaft bearing over 128 seconds shows 6 index cycles of the prover. Random impacting can be felt on each index cycle. These are shown as transient spikes on the time waveform. The impacts feel particularly strong in one position on the gearbox output shaft suggesting a possible problem with the output crown gear. Further investigation is warranted. Note: The prover was emptying when readings were taken.

The PeakVue time waveform recorded on the main gearbox output shaft bearing over 128 seconds shows 6 index cycles of the prover. Random impacting can be felt on each index cycle. These are shown as transient spikes on the time waveform. The impacts feel particularly strong in one position on the gearbox output shaft suggesting a possible problem with the output crown gear. Further investigation is warranted.

**Investigate:** - Remove the guard top cover and gearbox oil filler cap and inspect the crown gear for wear / damage. Note: The input worm gear may obscure view so an endoscope may be required. Also consider draining and flushing the lubricant checking for debris.

**Investigate: - Remove the guard top cover and gearbox oil filler cap and inspect the crown gear for wear / damage. Note: The input worm gear may obscure view so an endoscope may be required. Also consider draining and flushing the lubricant checking for debris.**

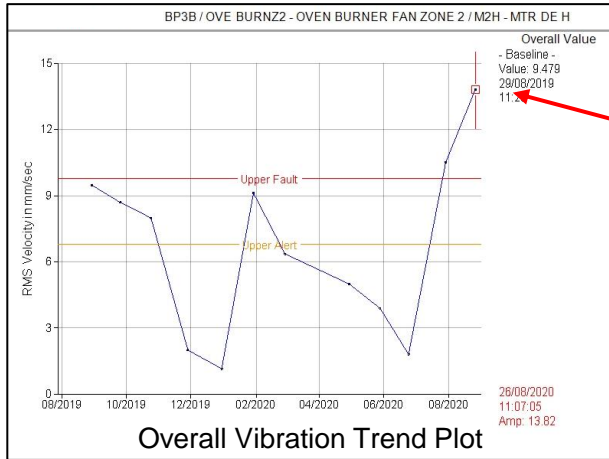
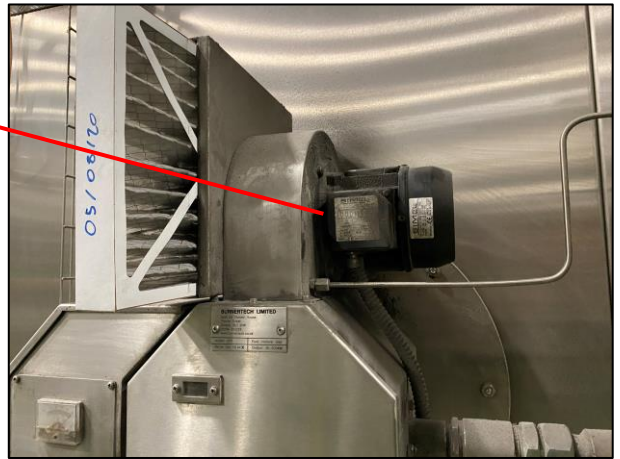
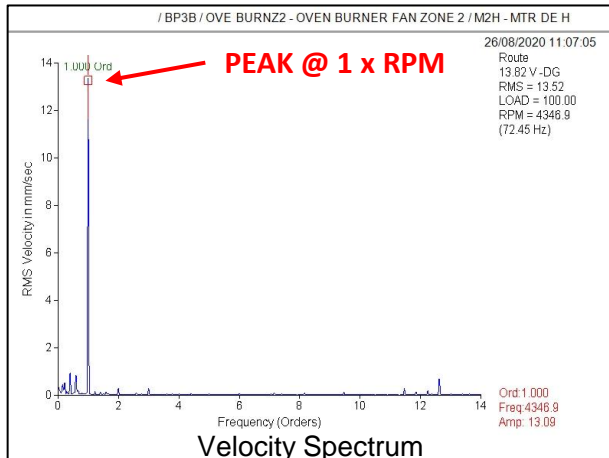
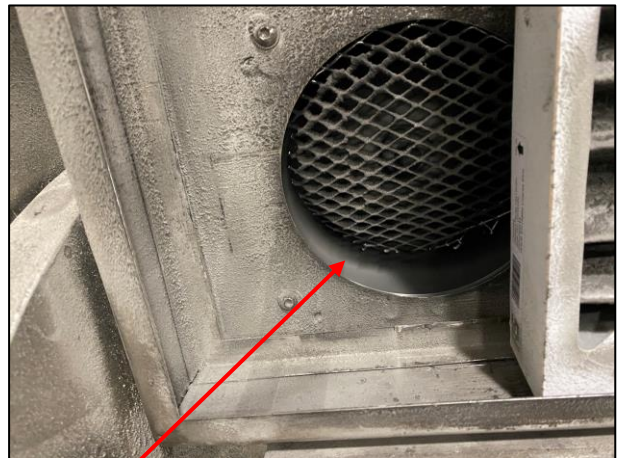
## BP 3 – OVEN BURNER 2 - COMBUSTION FAN

Overall vibration velocity measured on the fan motor sits above alarm levels. The spectrum shows most of this vibration is at fan running speed indicating imbalance. This is most likely due to uneven build-up of dirt / debris on the fan impeller. Note: The finger guard on the fan inlet is loose and rubbing on the fan impeller.

Overall vibration velocity measured on the fan motor sits above alarm levels. The spectrum shows most of this vibration is at fan running speed indicating imbalance. This is most likely due to uneven build-up of dirt / debris on the fan impeller.

Note: The finger guard on the fan inlet is loose and rubbing on the fan impeller.

**Clean the fan impeller. Re-secure the fan inlet guard.**

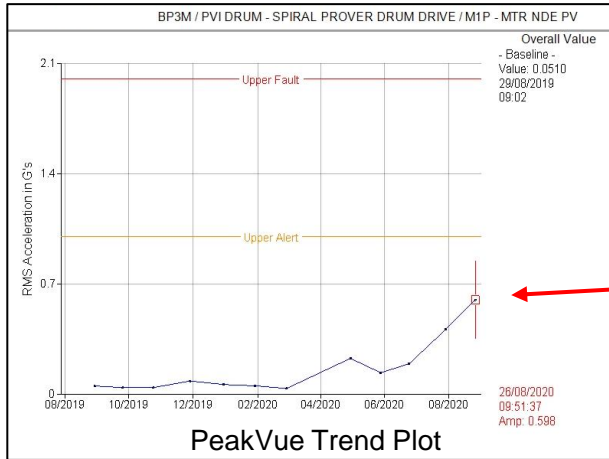
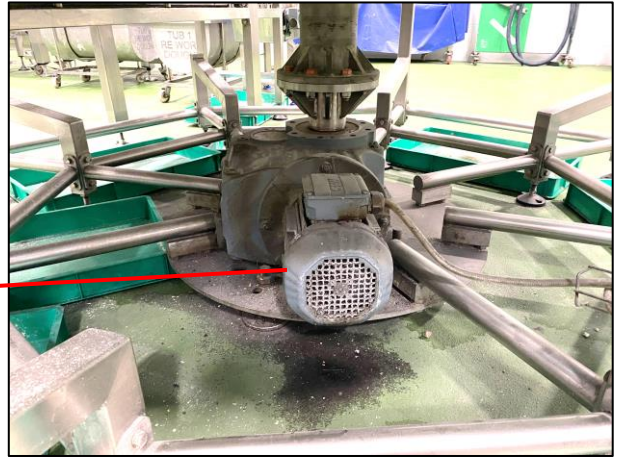
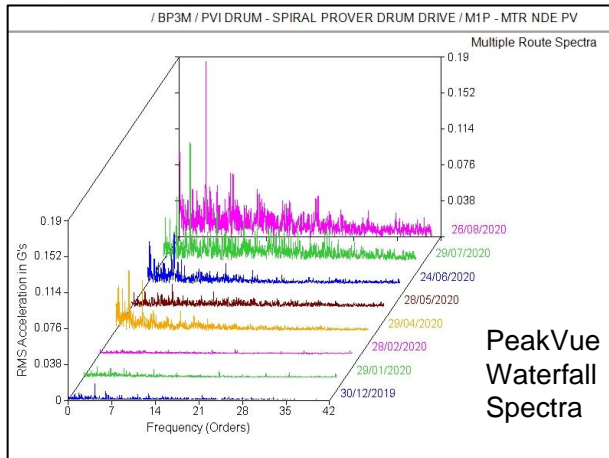
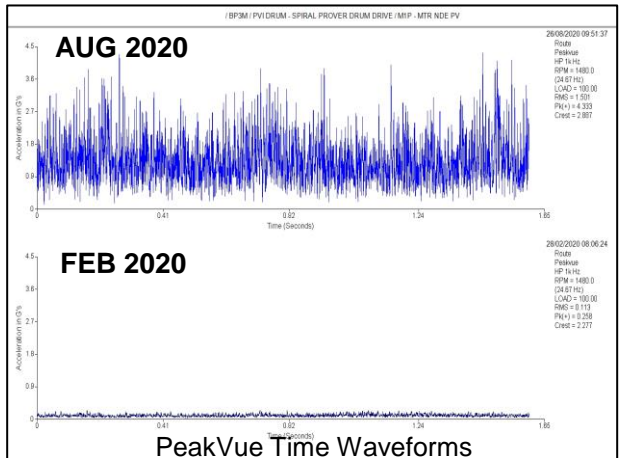
## BP 3 – SPIRAL PROVER MAIN DRIVE GEARMOTOR – MTR NDE

PeakVue measured on the motor NDE has been trending upwards over the last few visits. The waterfall spectra shows the increase in broadband vibration. The time waveforms taken six months apart show the increase in random high frequency vibration. This is most likely due the progression of bearing fatigue. The drive is not operating smoothly.

Overhaul the motor bearings.

**Overhaul the motor bearings.**

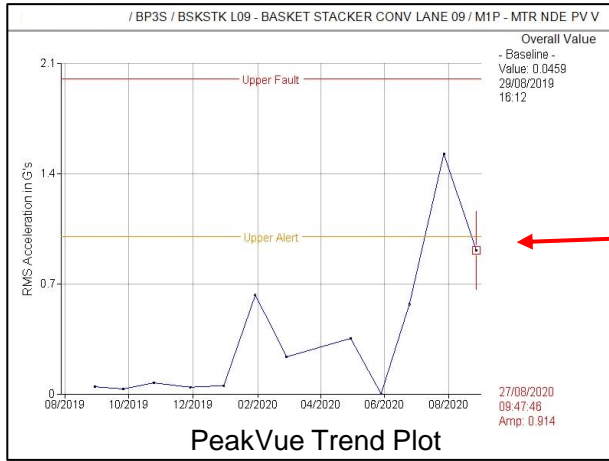
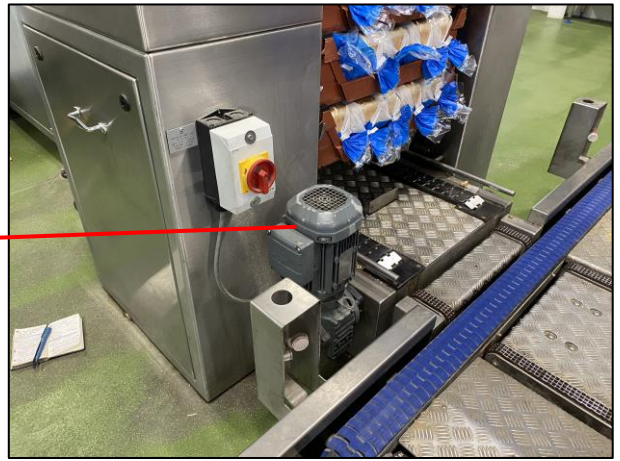
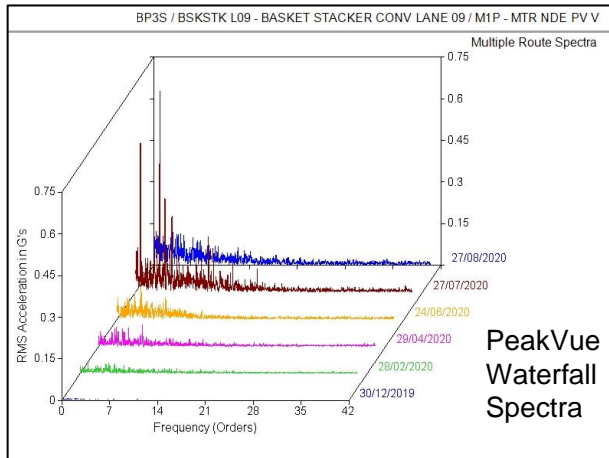
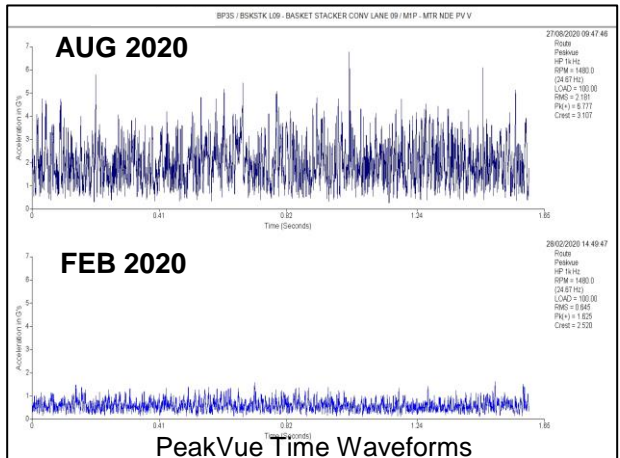
# BP 3 – LINE 9 BASKET STACKER OUTFEED CONV GEARMOTOR – MTR NDE

PeakVue measured on the motor NDE has dropped back just below alarm but remains above previous low running levels. The waterfall spectra shows the increase in broadband vibration over recent visits. The time waveforms taken six months apart show the increase in signal level.

**Overhaul the motor bearings.**

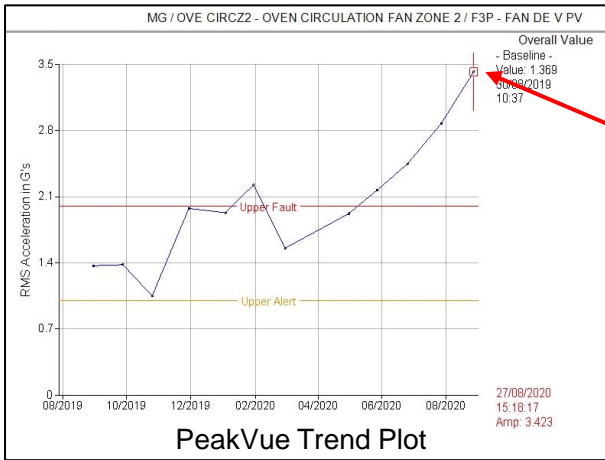
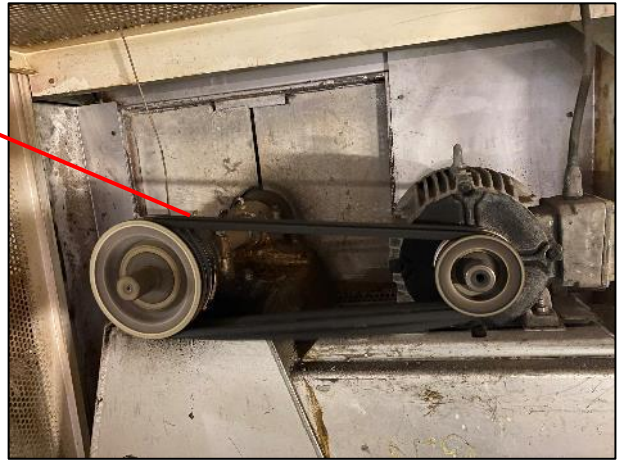
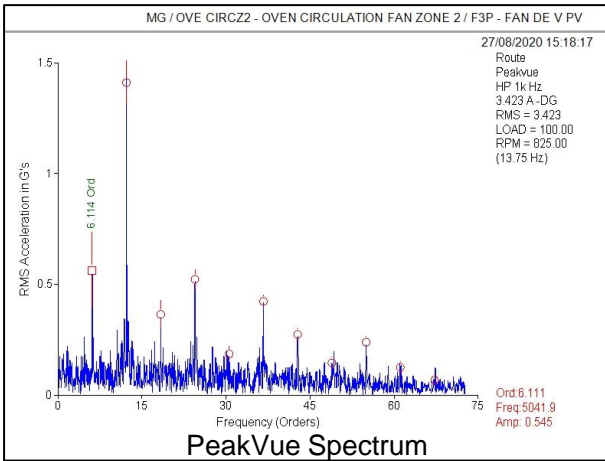
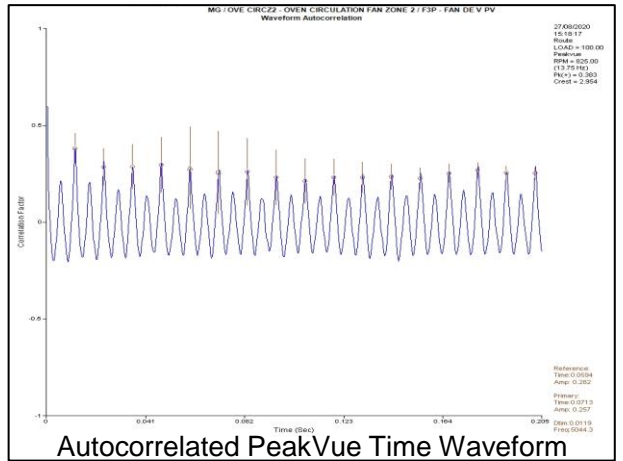
# MG OVEN – CIRCULATION FAN 2 – FAN SHAFT DE BEARING

PeakVue measured on the fan shaft DE bearing (nearest to pulley) has increased again this visit and sits well above alarm level 2. The spectrum shows a peak at 6.1 x running speed with harmonics. The time waveform shows impacting signals relating to the peak in the spectrum. These non-synchronous signals indicate a bearing defect is progressing on the fan shaft DE bearing.

Replace the fan shaft bearings soon.

**Replace the fan shaft bearings soon.**

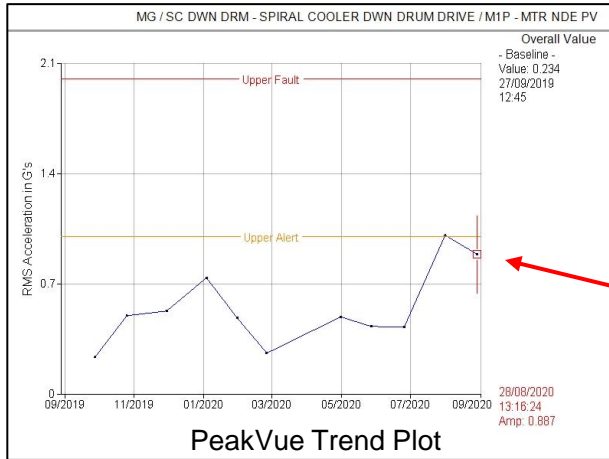
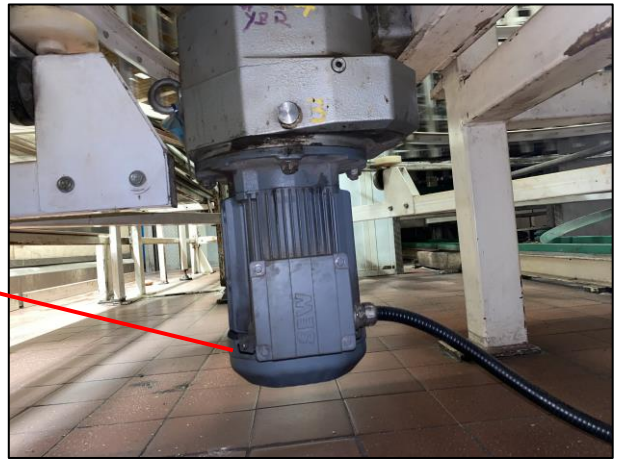
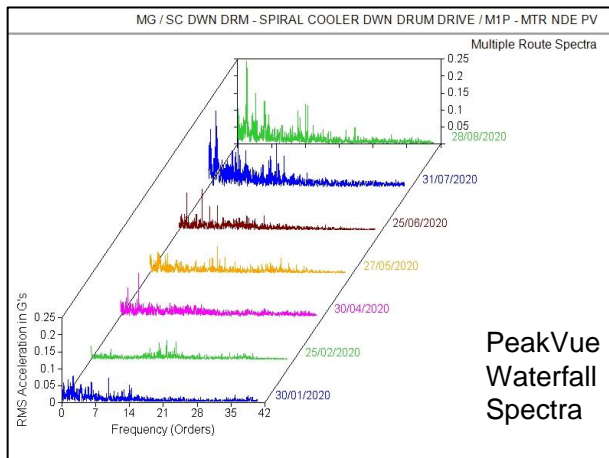
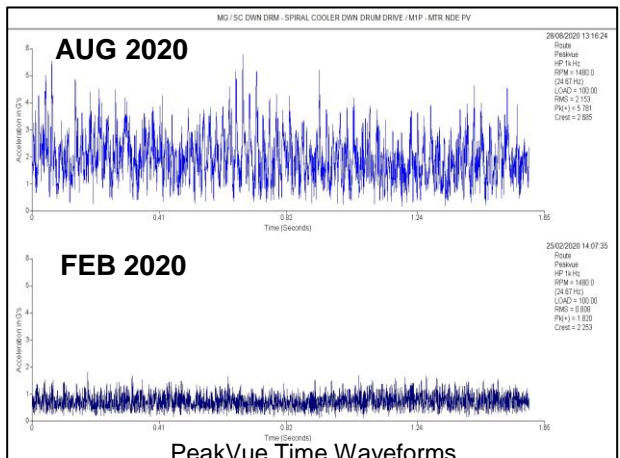
# MORNING GOODS – COOLER DOWN DRUM GEARMOTOR – MTR NDE

PeakVue measured on the motor NDE has dropped just below alarm level 1 but remains above previous running levels. The waterfall spectra shows the increase in broadband vibration over recent visits. The time waveforms taken six months apart show the increase in signal level. The motor is not operating smoothly. This is most likely due to early stage bearing fatigue.

Consider overhauling the motor bearings.

**Consider overhauling the motor bearings.**

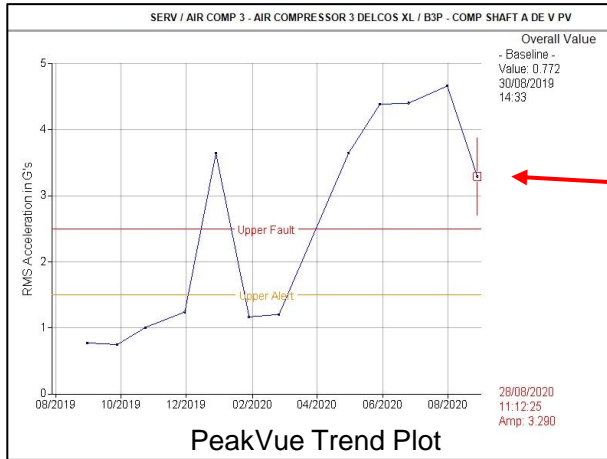
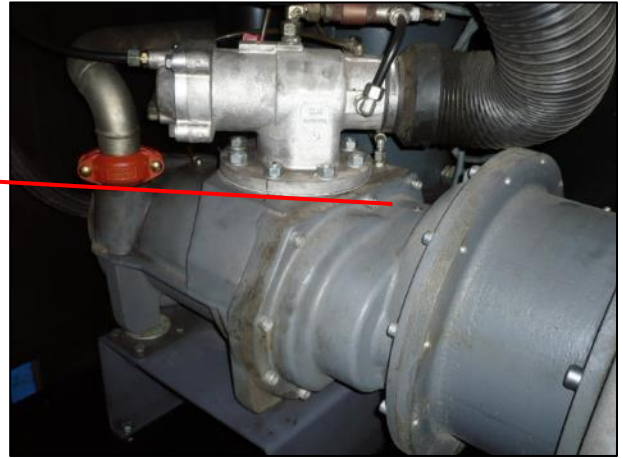
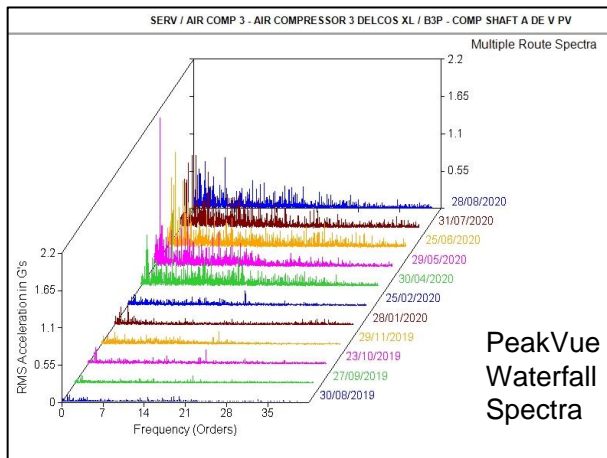
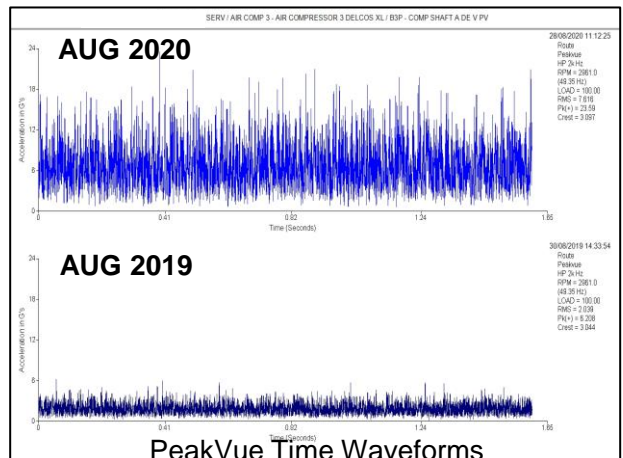
## SERVICES – AIR COMPRESSOR 3 (DELCOS XL)

PeakVue measured on the compressor DE remains above alarm level 2. The waterfall spectra shows the increase in broadband vibration over recent visits. The time waveforms taken a year apart show the increase in signal level. Similar increases are also evident on other measurement positions on the compressor but the highest signal levels are present on the compressor input gear casing. This may be due to wear in the compressor gears / bearings.

**Split the compressor from the motor and inspect the gears / bearings for wear / damage. Consider sending an oil sample for analysis to check for wear particles.**

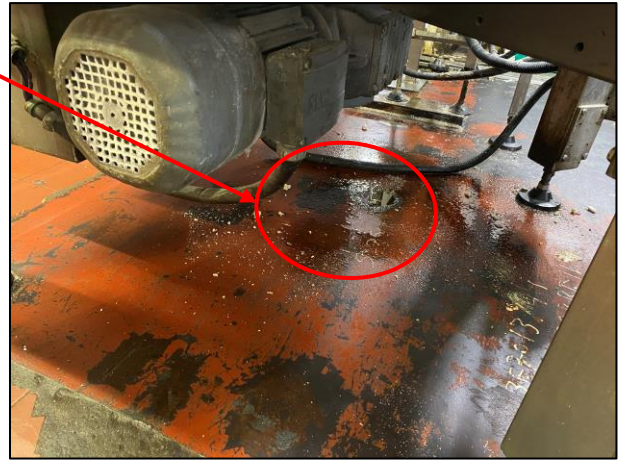
### ➤ Bread Plant 1 – Rounder Gearmotor

Oil is weeping from the gearbox output shaft seal and there's a pool of oil on the floor under the gearbox.

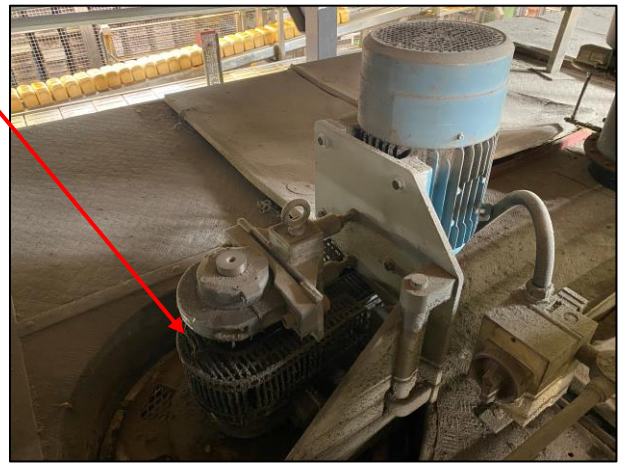
### ➤ Bread Plant 1 – Oven Circulation Fans

Circulation fan 5 has a broken drive belt and the others are cracked. Circulation fans 3, 6 & 7 all have badly cracked drive belts. Replace the drive belts on these fans.

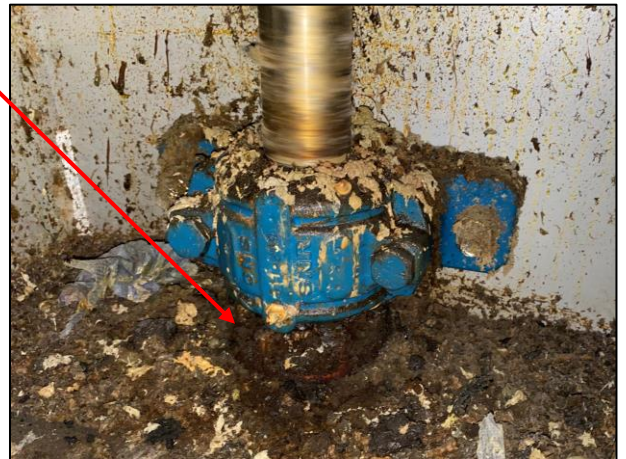
### ➤ Bread Plant 2 – Oven Circulation Fan 5

The heat shield below the bottom fan shaft bearing is not turning. This needs refitting to the fan shaft to deflect the heat away from the bearing.

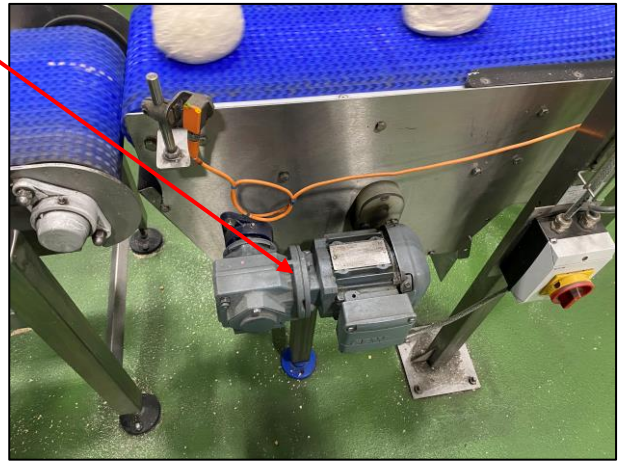
➤ **Bread Plant 3 – Rounder Outfeed Conveyor A9**

The drive shaft is worn in the drive side shaft bearing.

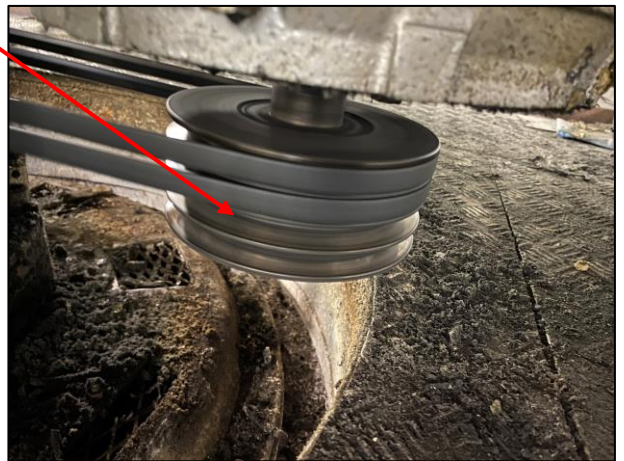
➤ **Bread Plant 3 – Oven Circulation Fan 2**

Two of the drive belts are missing.

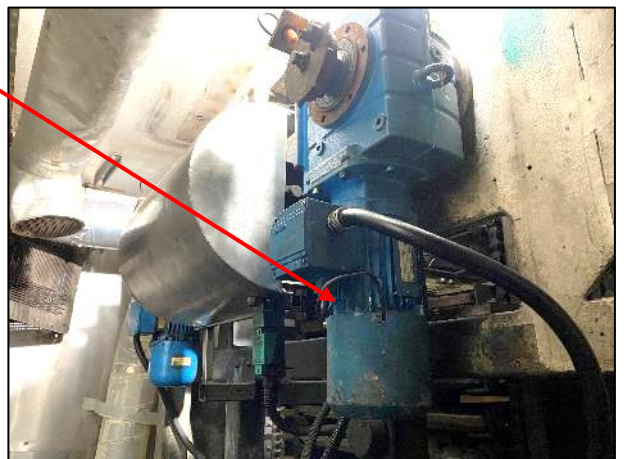
➤ **Morning Goods – Prover Raise Gearmotor (Side nearest to BP1)**

The brake is very noisy when energising. This may be due to a worn brake disk / excessive brake gap. Check / adjust the brake gap.

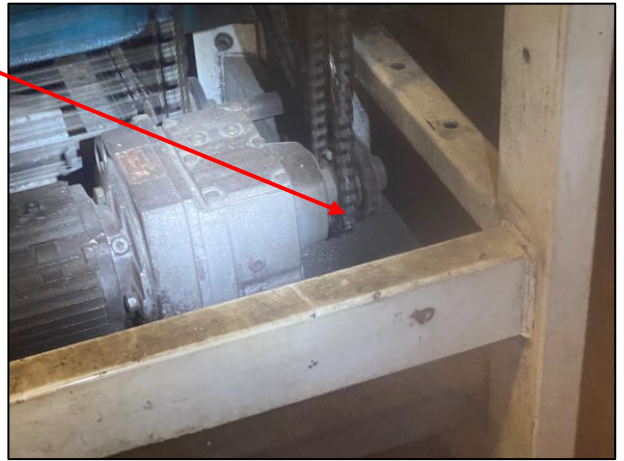
- **Morning Goods Cooler – Overdrive below cooler outfeed conveyor**  
The drive chain is slack and jumping on the drive sprocket.

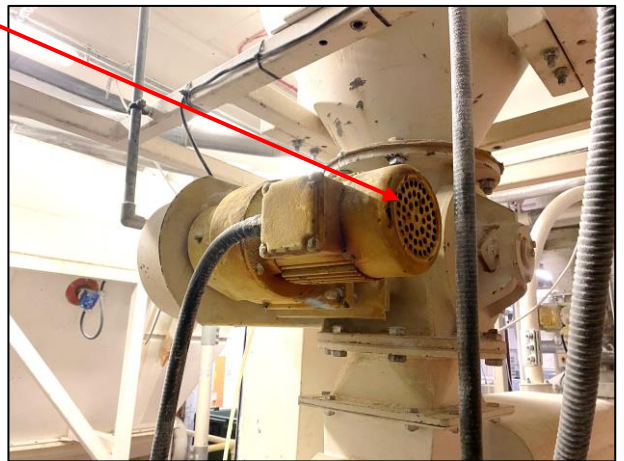
- **Flour Room – Morning Goods White Sieve Infeed Rotary Valve**  
The motor cooling fan is not turning. It needs re-securing to the motor shaft.

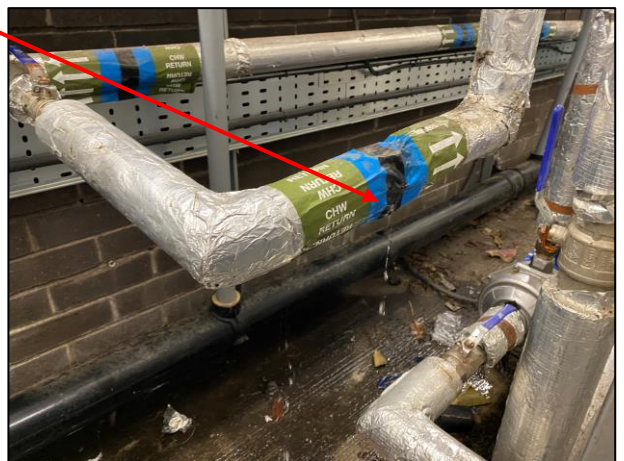
- **Chiller Room Adjacent to Air Compressor 3**  
There is water leaking from the chilled water return pipe behind chiller No.2
