# THERMOGRAPHIC SURVEY OF PLANT AND EQUIPMENT

## SAMPLE REPORT

2.1 A Thermographic Survey of the **Bakery, Services and Ancillary Equipment** was carried out on the **10<sup>th</sup> September 2020** on behalf of **On Line Vibration Monitoring Ltd, Cumbria**. This is a report on the conditions prevailing when the items in the schedule were inspected.

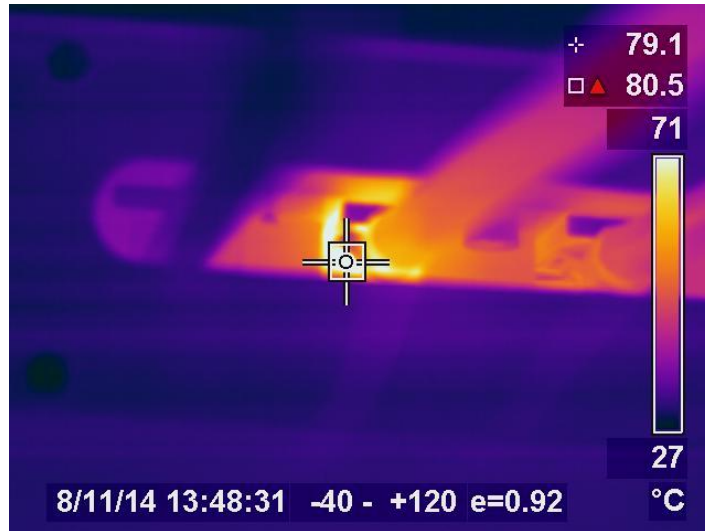
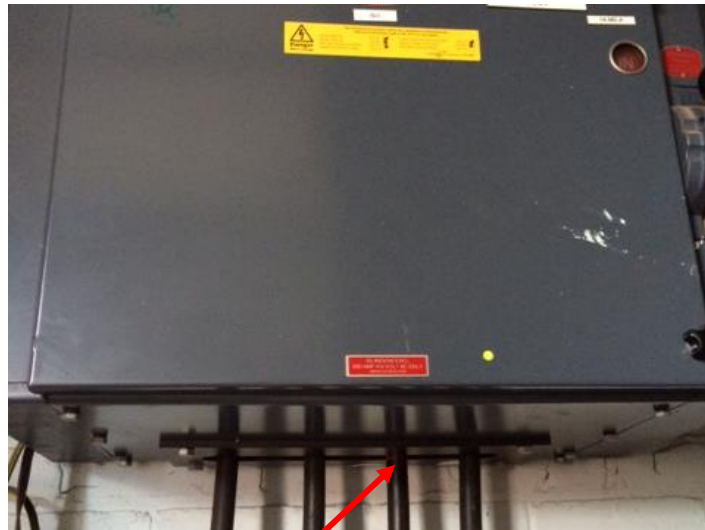
<b>Client</b>	On Line Vibration Monitoring Ltd	<b>Report No.</b>	IR 001
<b>Location</b>	External LV Switch room	<b>Asset No.</b>	
<b>Plant Item</b>	Main Switch Fuse No.1

<p><b>Fault Description</b>  Bottom connection L3 (marked as red phase). Thermogram taken looking up from under the switch.  Temp. Rise = 30°C    Max. Temp. = 80°C</p>	<p style="text-align: center;"><b>Severity</b></p> <div style="text-align: center;"> </div> <p><i>Critical</i></p> <hr/> <p><i>Inspect / Rectify</i></p> <hr/> <p><i>Inspection Required</i></p>
<p><b>Possible Cause</b>  Defective Connection</p>	
<p><b>Recommended Action</b>  Open fused switch and inspect crimp lug, connection and switch contacts</p>

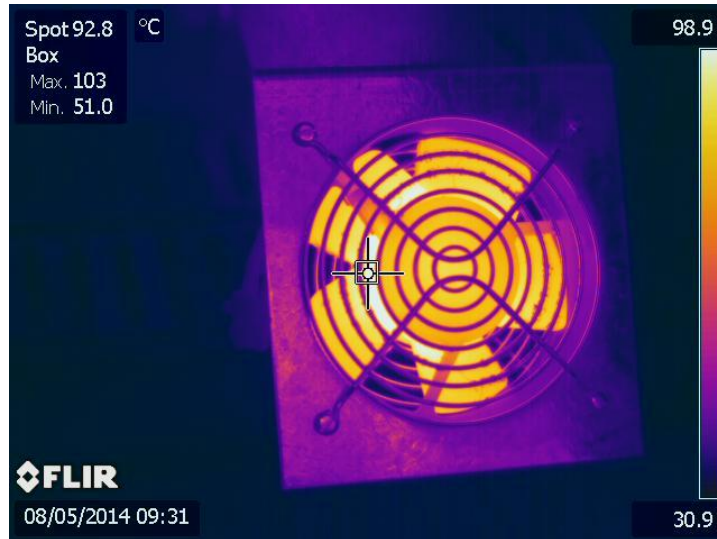
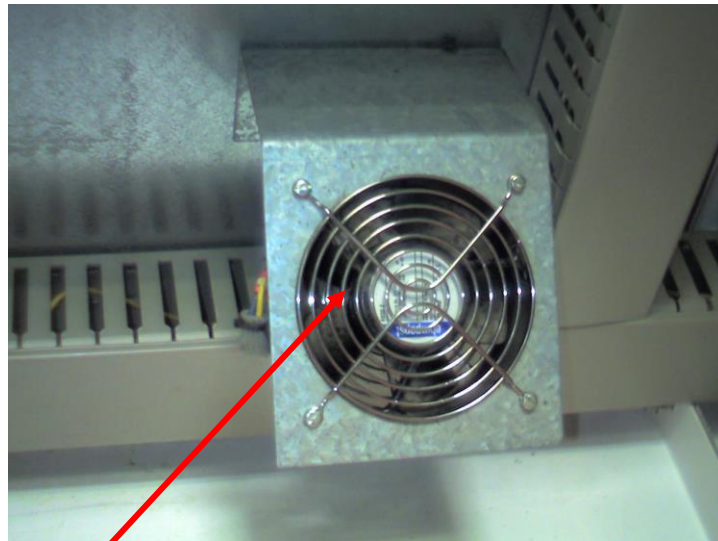
<b>Client</b>	On Line Vibration Monitoring Ltd	<b>Report No.</b>	IR 002
<b>Location</b>	Bread Plant (Oven / Prover Area)	<b>Asset No.</b>	
<b>Plant Item</b>	Oven control panel – Zone 2 section

<p><b>Fault Description</b>          Stalled panel cooling fan          Temp. Rise = 56°C          Max. Temp. = 103°C</p>	<p style="text-align: center;"><b>Severity</b></p> <div style="display: flex; align-items: center;"> <div style="margin-right: 10px;"> <p><b>Critical</b></p> <hr style="width: 50px;"/> <p><b>Inspect / Rectify</b></p> <hr style="width: 50px;"/> <p><b>Inspection Required</b></p> </div>

</div>
<p><b>Possible Cause</b>          Defective / stalled fan</p>	
<p><b>Recommended Action</b>          Replace the cooling fan</p>

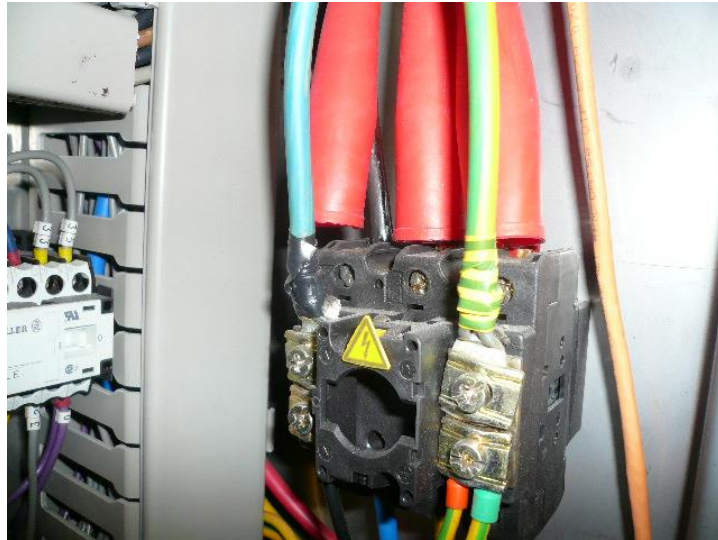
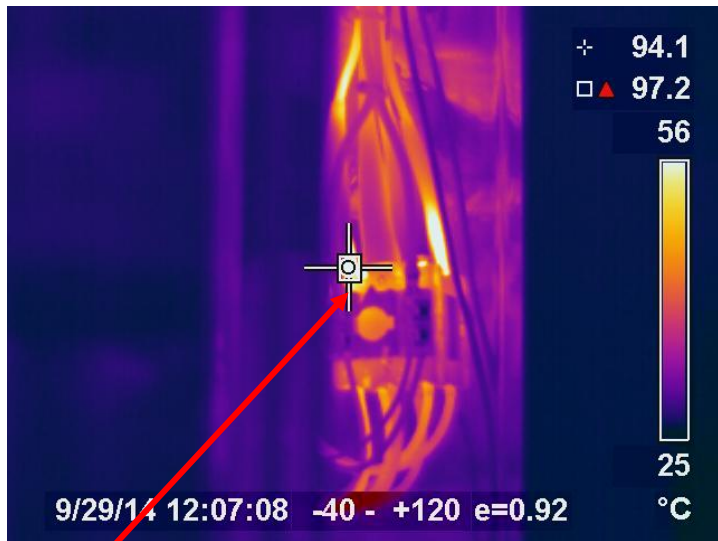
<b>Client</b>	On Line Vibration Monitoring Ltd	<b>Item No.</b>	IR 003
<b>Location</b>	Bread Plant 1	<b>Asset No.</b>	
<b>Plant Item</b>	Tin Cleaner Control Panel (ex tin stores)

<p><b><u>Fault Description</u></b>          Brown phase top (incoming) connection on panel isolator          Also – grey phase top (incoming) although to a lesser extent          Temp Rise = 47°C</p>	<p style="text-align: center;"><b><u>Severity</u></b></p> <div style="text-align: center;"> </div> <p><b><i>Critical</i></b></p> <hr/> <p><b><i>Inspect / Rectify</i></b></p> <hr/> <p><b><i>Inspection Required</i></b></p>
<p><b><u>Possible Cause</u></b>          Defective / loose connections</p>	
<p><b><u>Recommended Action</u></b>          Cut back cables and remake connections</p>

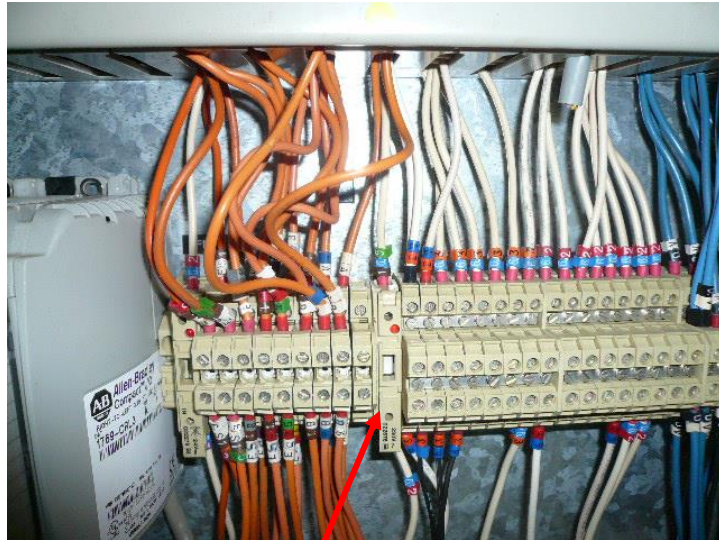
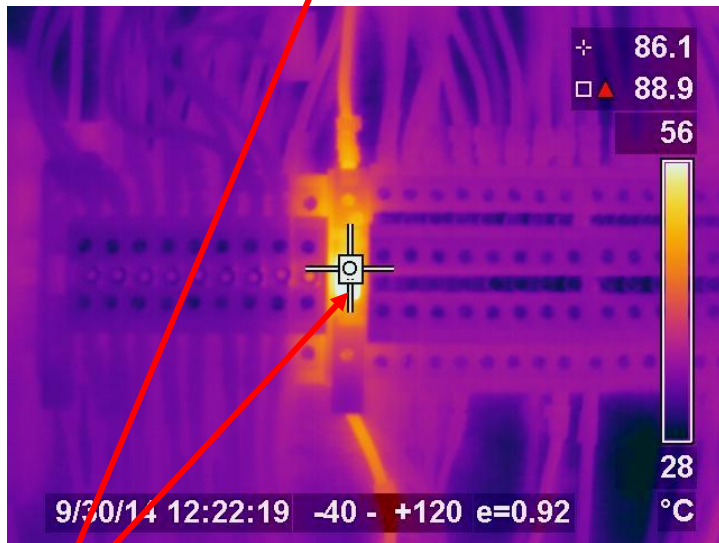
<b>Client</b>	On Line Vibration Monitoring Ltd	<b>Item No.</b>	IR 004
<b>Location</b>	Despatch	<b>Asset No.</b>	
<b>Plant Item</b>	Basket Storage Control Panel - RH section

<p><b><u>Fault Description</u></b> Terminal rail fuse (to the right of the PLC) Temp Rise = 47°C, Temp Max = 88°C</p>	<p style="text-align: center;"><b><u>Severity</u></b></p> <div style="text-align: center;"> <p><b>Critical</b></p> <p>_____</p> <p><b>Inspect / Rectify</b></p> <p>_____</p> <p><b>Inspection Required</b></p> </div>
<p><b><u>Possible Cause</u></b> High load – This fuse supplies the Pilz relay and numerous contactor coils</p>	
<p><b><u>Recommended Action</u></b> Consider splitting the circuit or uprating the fuse holder</p>

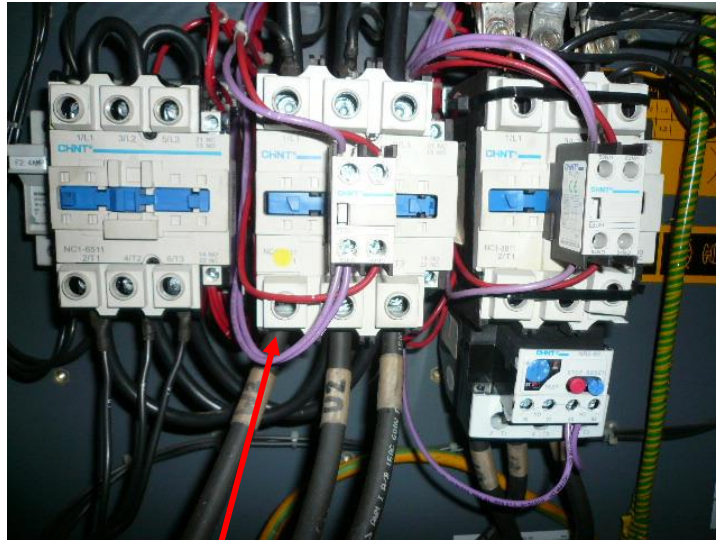
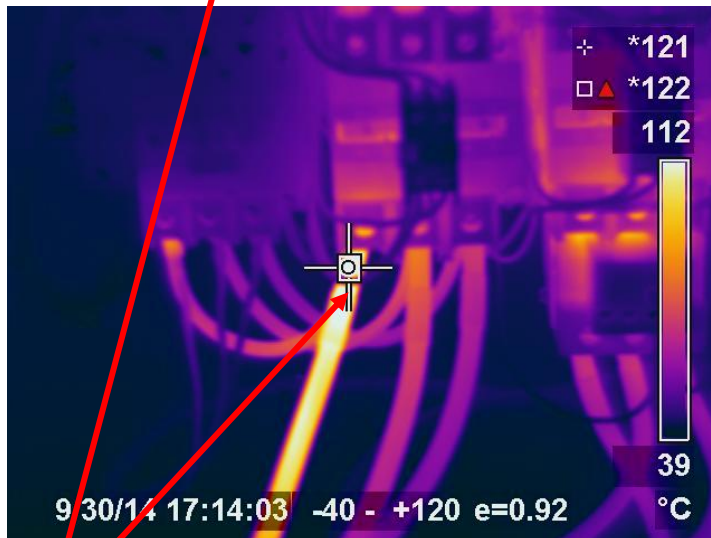
<b>Client</b>	On Line Vibration Monitoring Ltd	<b>Item No.</b>	IR 005
<b>Location</b>	Compressor House	<b>Asset No.</b>	
<b>Plant Item</b>	Compressor No.1 Control Panel

<p><b>Fault Description</b> Delta contactor bottom L1 connection (Wire No. W2) Temp Rise = 36°C, Max Temp = 122 °C</p>	<p style="text-align: center;"><b>Severity</b></p> <div style="text-align: center;"> <p><i>Critical</i></p> <div style="display: flex; align-items: center;"> <div style="width: 10px; height: 20px; background-color: red; margin-right: 5px;"></div> <div style="width: 10px; height: 20px; background-color: orange; margin-right: 5px;"></div> <div style="width: 10px; height: 20px; background-color: yellow; margin-right: 5px;"></div> </div> <p>←</p> <p><i>Inspect / Rectify</i></p> <hr style="width: 50%; margin: 5px auto;"/> <p><i>Inspection Required</i></p> </div>
<p><b>Possible Cause</b> Loose connection</p>	
<p><b>Recommended Action</b> Tighten / remake connection</p>

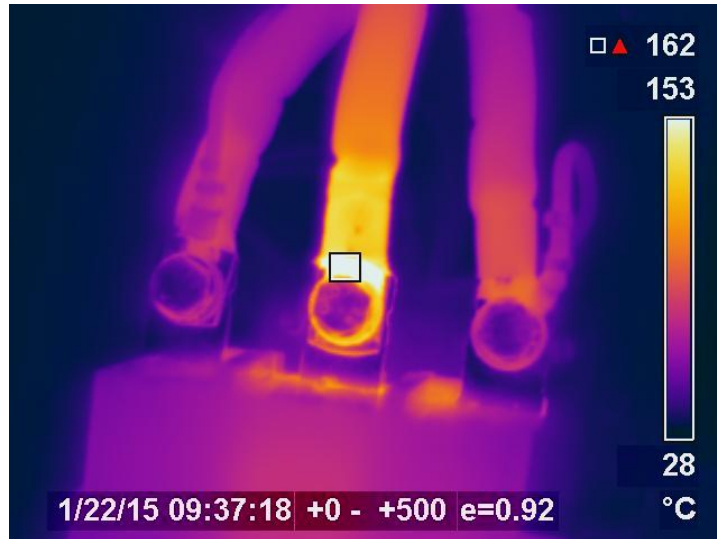
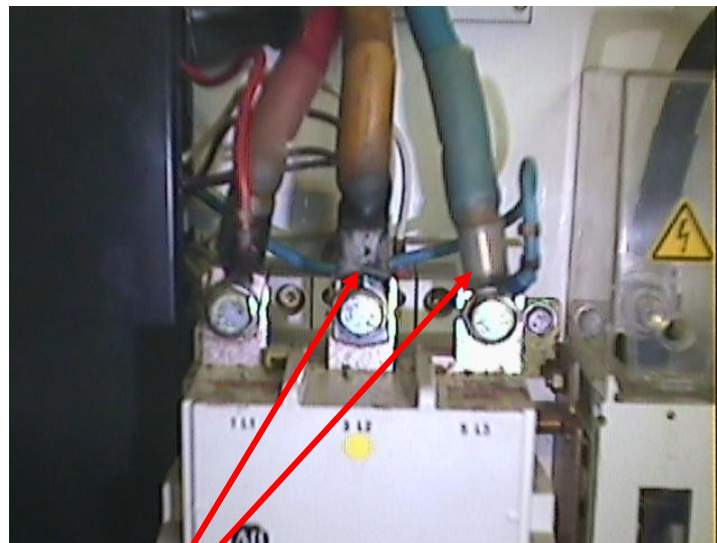
<b>Client</b>	On Line Vibration Monitoring Ltd	<b>Report No.</b>	IR 006
<b>Location</b>	Bread Plant	<b>Asset No.</b>	
<b>Plant Item</b>	Oven control panel

<p><b>Fault Description</b>  Top L2 and L3 connections on Safety Contactor 'SC'  Temp. Rise = 120°C  Max. Temp. = 162 °C</p>	<p style="text-align: center;"><b>Severity</b></p> <div style="display: flex; align-items: center;"> <div style="margin-right: 10px;"> <p><b>Critical</b></p> <hr style="width: 50%; margin: 5px 0;"/> <p><b>Inspect / Rectify</b></p> <hr style="width: 50%; margin: 5px 0;"/> <p><b>Inspection Required</b></p> </div>

</div>
<p><b>Possible Cause</b>  Defective connections</p>	
<p><b>Recommended Action</b>  The previous repair has not resolved the problem so consider replacing the 50mm<sup>2</sup> tails and the safety contactor.</p>

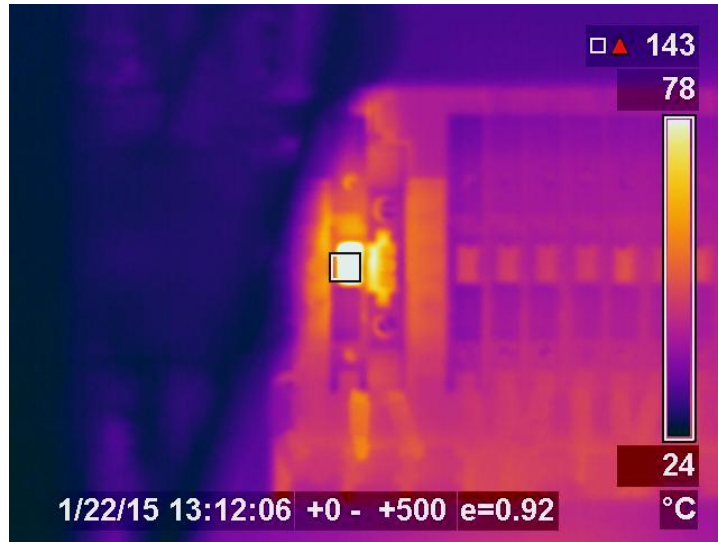
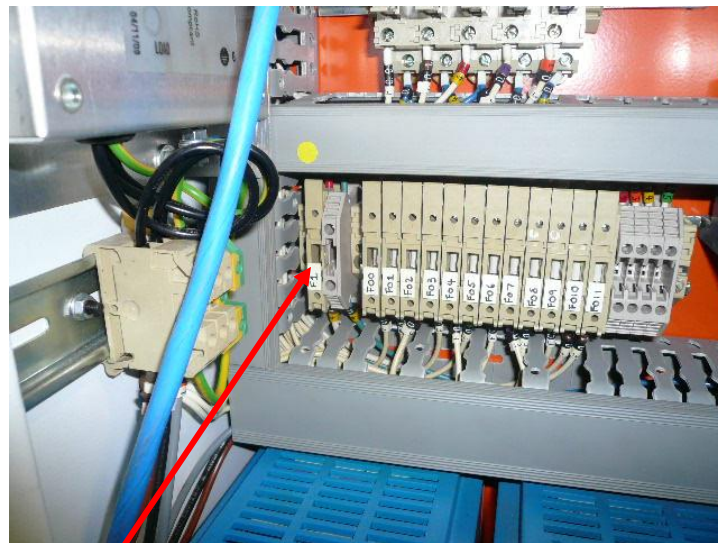
<b>Client</b>	On Line Vibration Monitoring Ltd	<b>Report No.</b>	IR 007
<b>Location</b>	Bread Plant	<b>Asset No.</b>	
<b>Plant Item</b>	Wrapper D Control Panel

<p><b><u>Fault Description</u></b>  DIN rail fused terminal 'F1'  Temp. Rise = 95°C  Max. Temp. = 143 °C</p>	<p style="text-align: center;"><b><u>Severity</u></b></p> <div style="text-align: center;"> <p><b>Critical</b></p> <div style="display: flex; align-items: center;"> <div style="width: 10px; height: 20px; background-color: red; margin-right: 5px;"></div> <div style="font-size: 2em;">←</div> </div> <p><b>Inspect / Rectify</b></p> <div style="display: flex; align-items: center;"> <div style="width: 10px; height: 20px; background-color: orange; margin-right: 5px;"></div> </div> <p><b>Inspection Required</b></p> <div style="display: flex; align-items: center;"> <div style="width: 10px; height: 20px; background-color: yellow; margin-right: 5px;"></div> </div> </div>
<p><b><u>Possible Cause</u></b>  Defective fuse carrier contacts</p>	
<p><b><u>Recommended Action</u></b>  Replace the fused terminal</p>

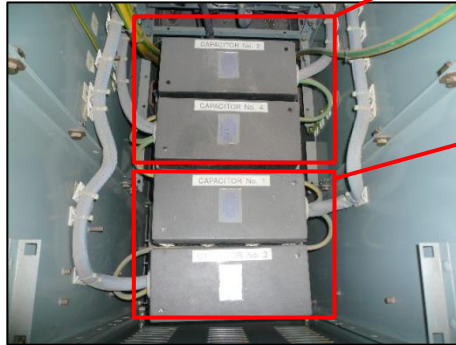
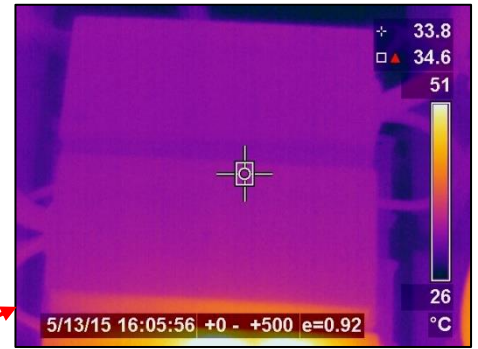
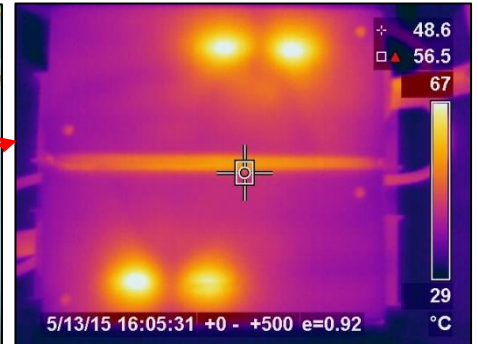
### ➤ LV Switchroom – Power Factor Correction

The power factor display was noted to be running at 0.87  $\cos\Phi$ . There are four banks of capacitor with six capacitors in each bank. All capacitor banks are energised but only four capacitors are shown to be loaded (see images).

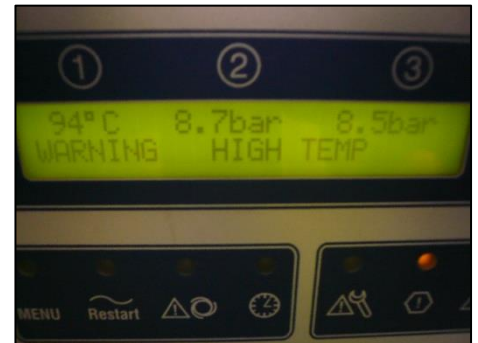
The Compair compressor is flashing a high temperature warning alarm

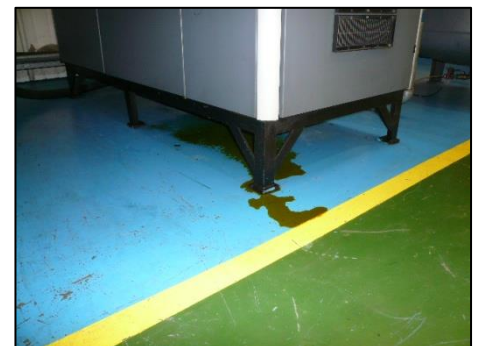
The Atlas Copco compressor is leaking oil onto the floor

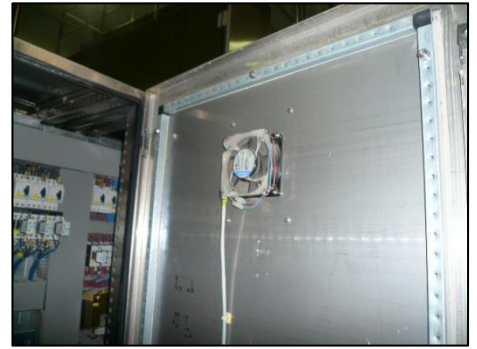
➤ **Bread Plant Cooler Control Panel**

There are a number of panel cooling fans not running on this panel suite.

Enclosure 2 – Top fan stalled

Enclosure 3 – Both fans not running

Enclosure 4 – Top fan not running
